Victoria to Esquimalt Cable Replacement Project – Update Presentation

Burnside-Gorge Community Association

Project Overview

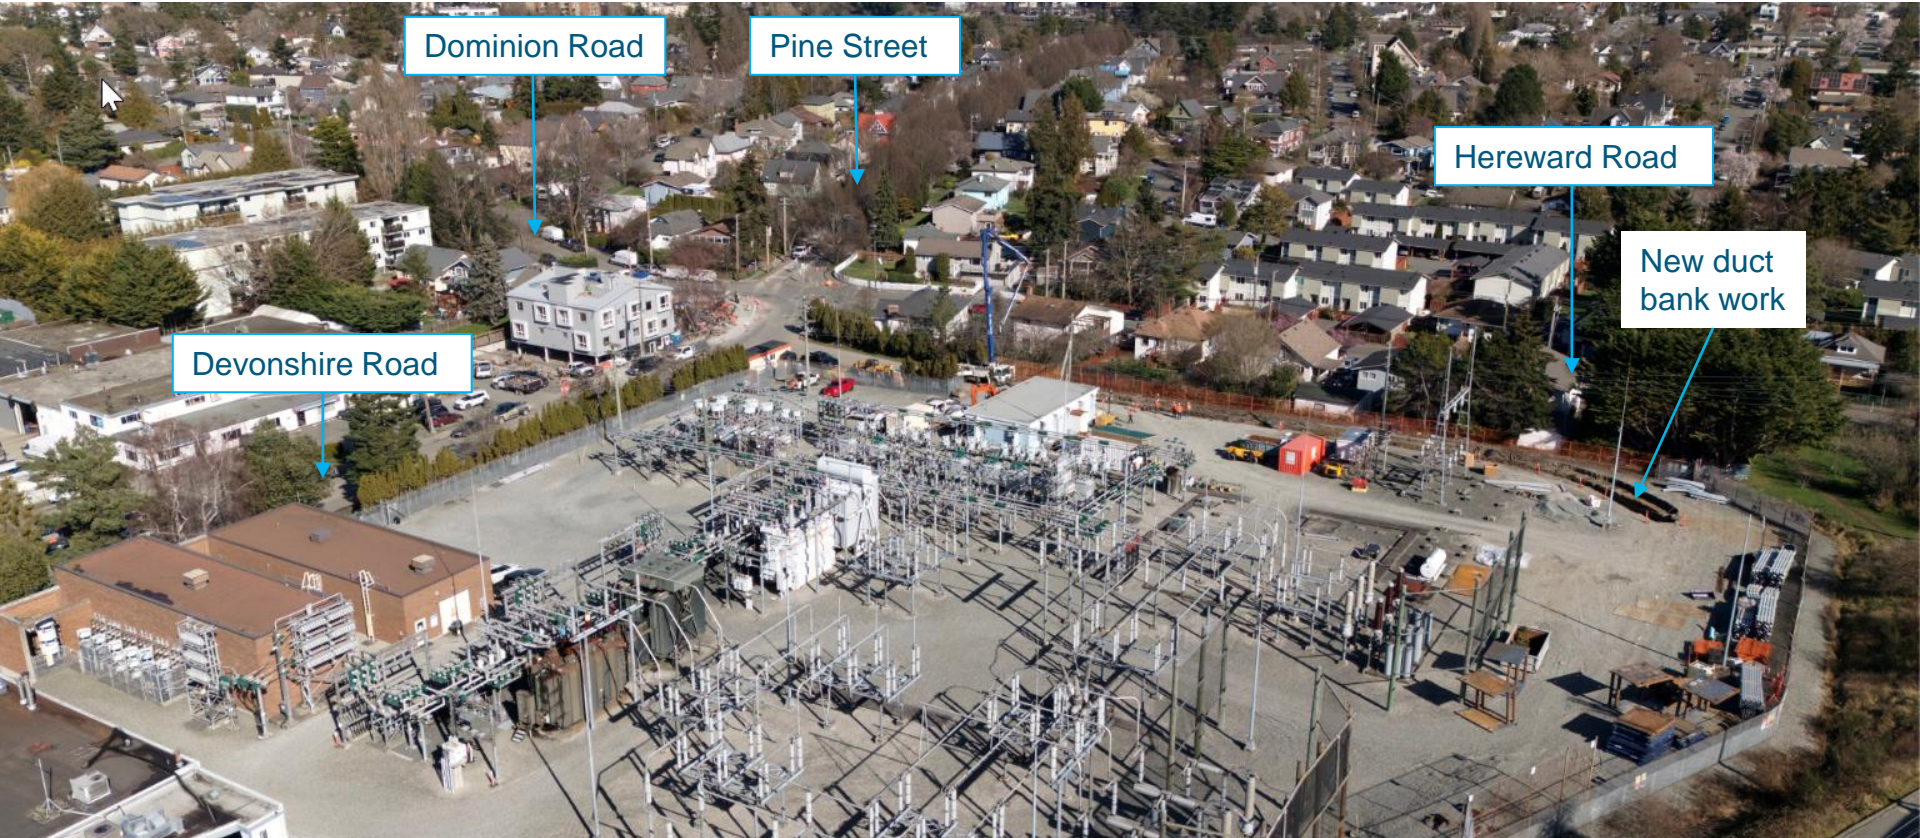
March 6: Photo of duct bank work within the Esquimalt Substation.

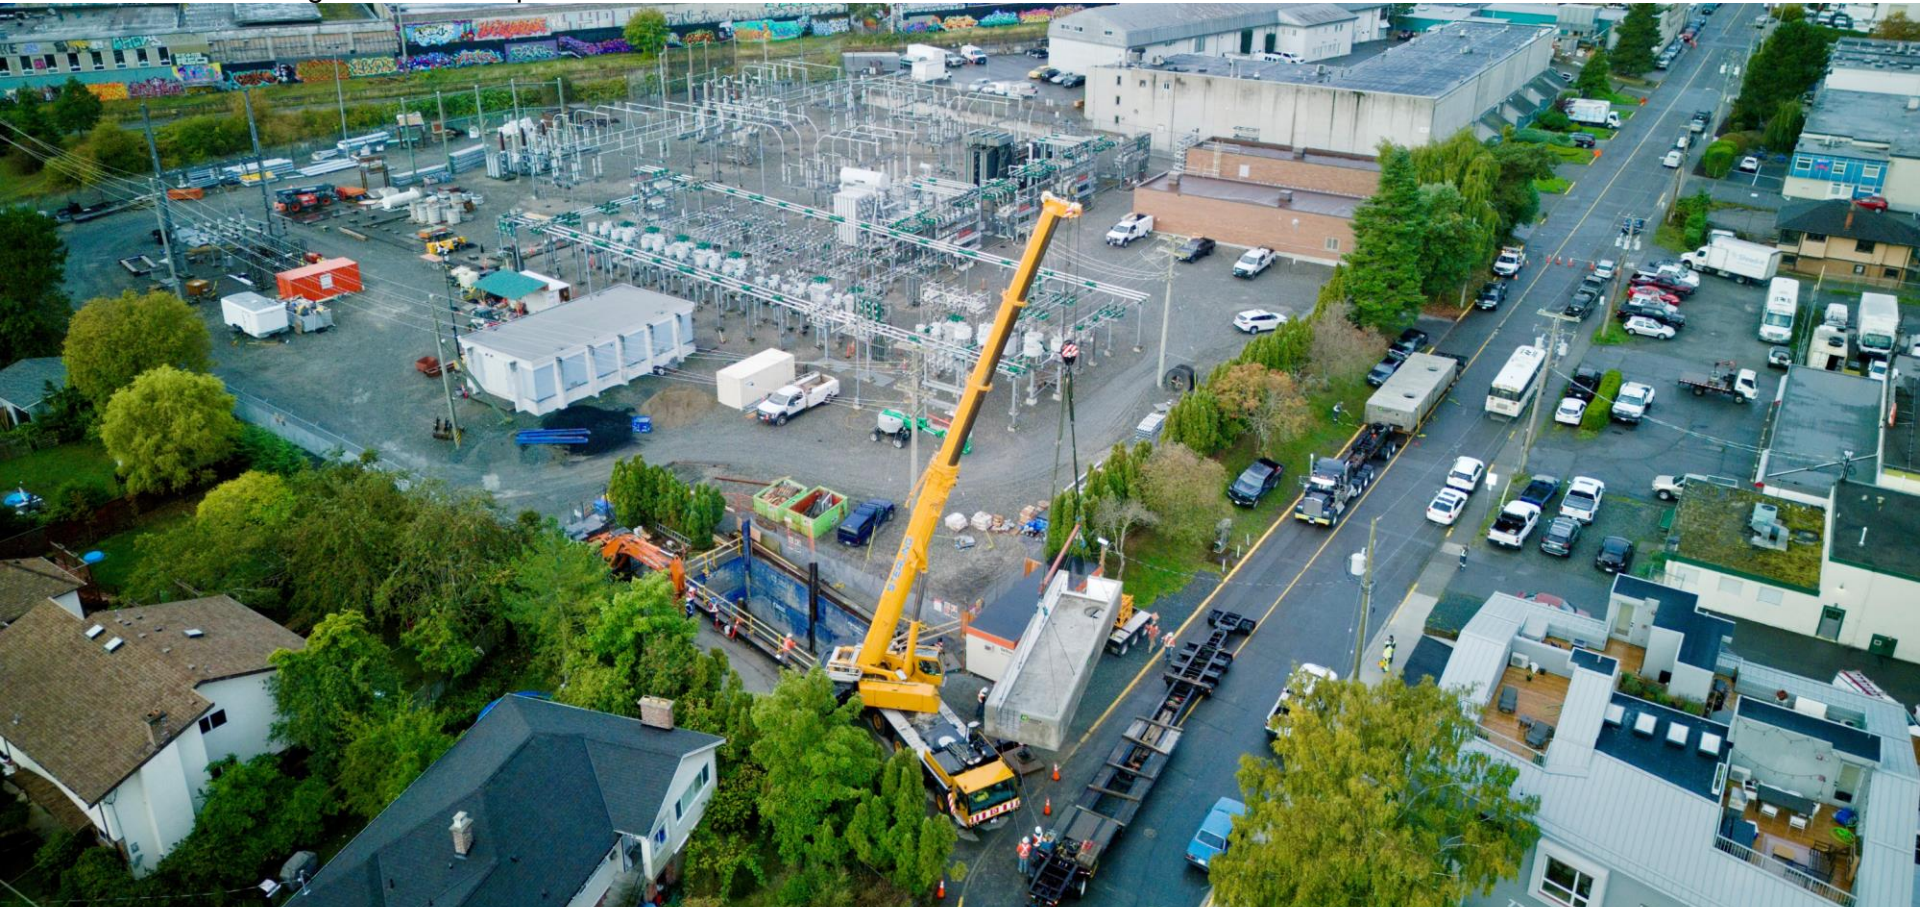
October 2: Placing the lower section of the concrete vault beside the access road into the substation. The upper section of the vault is on a truck to the right side of the photo on Devonshire Road.

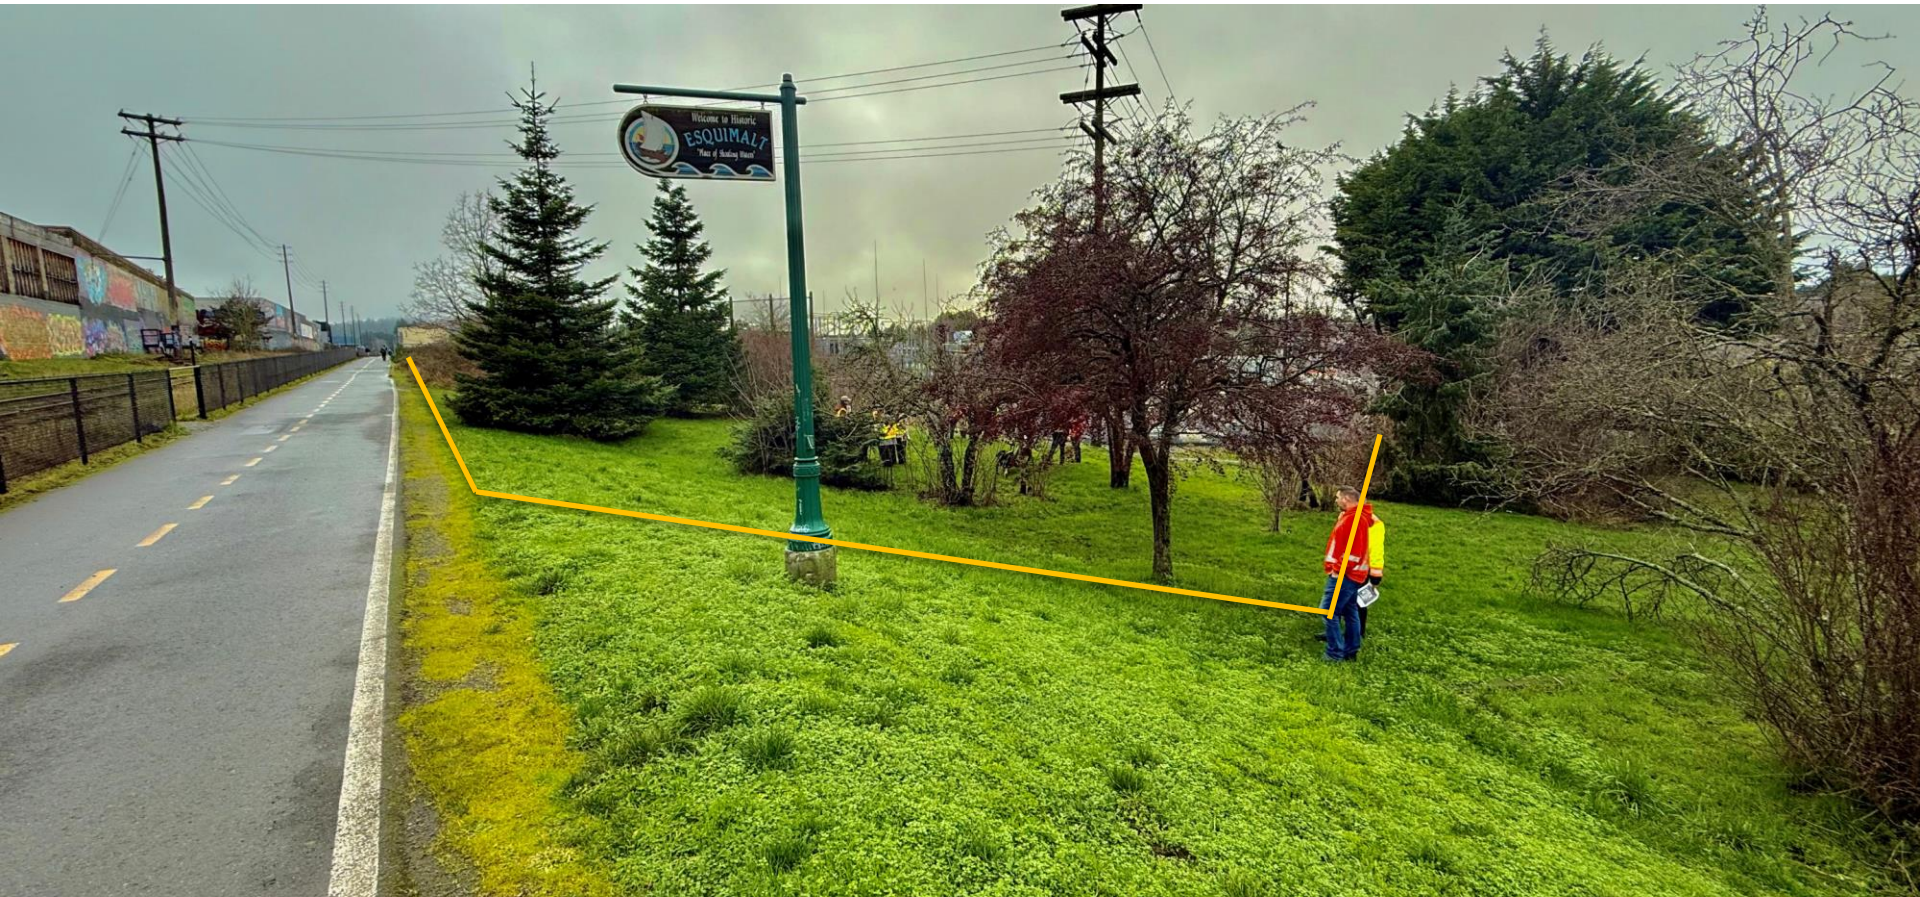
January 13: E&N Trail beside the substation lands and the adjacent City of Victoria park off Hereward Road. Work will begin in February to expand the substation footprint and place a fence beside the trail – **orange** lines.

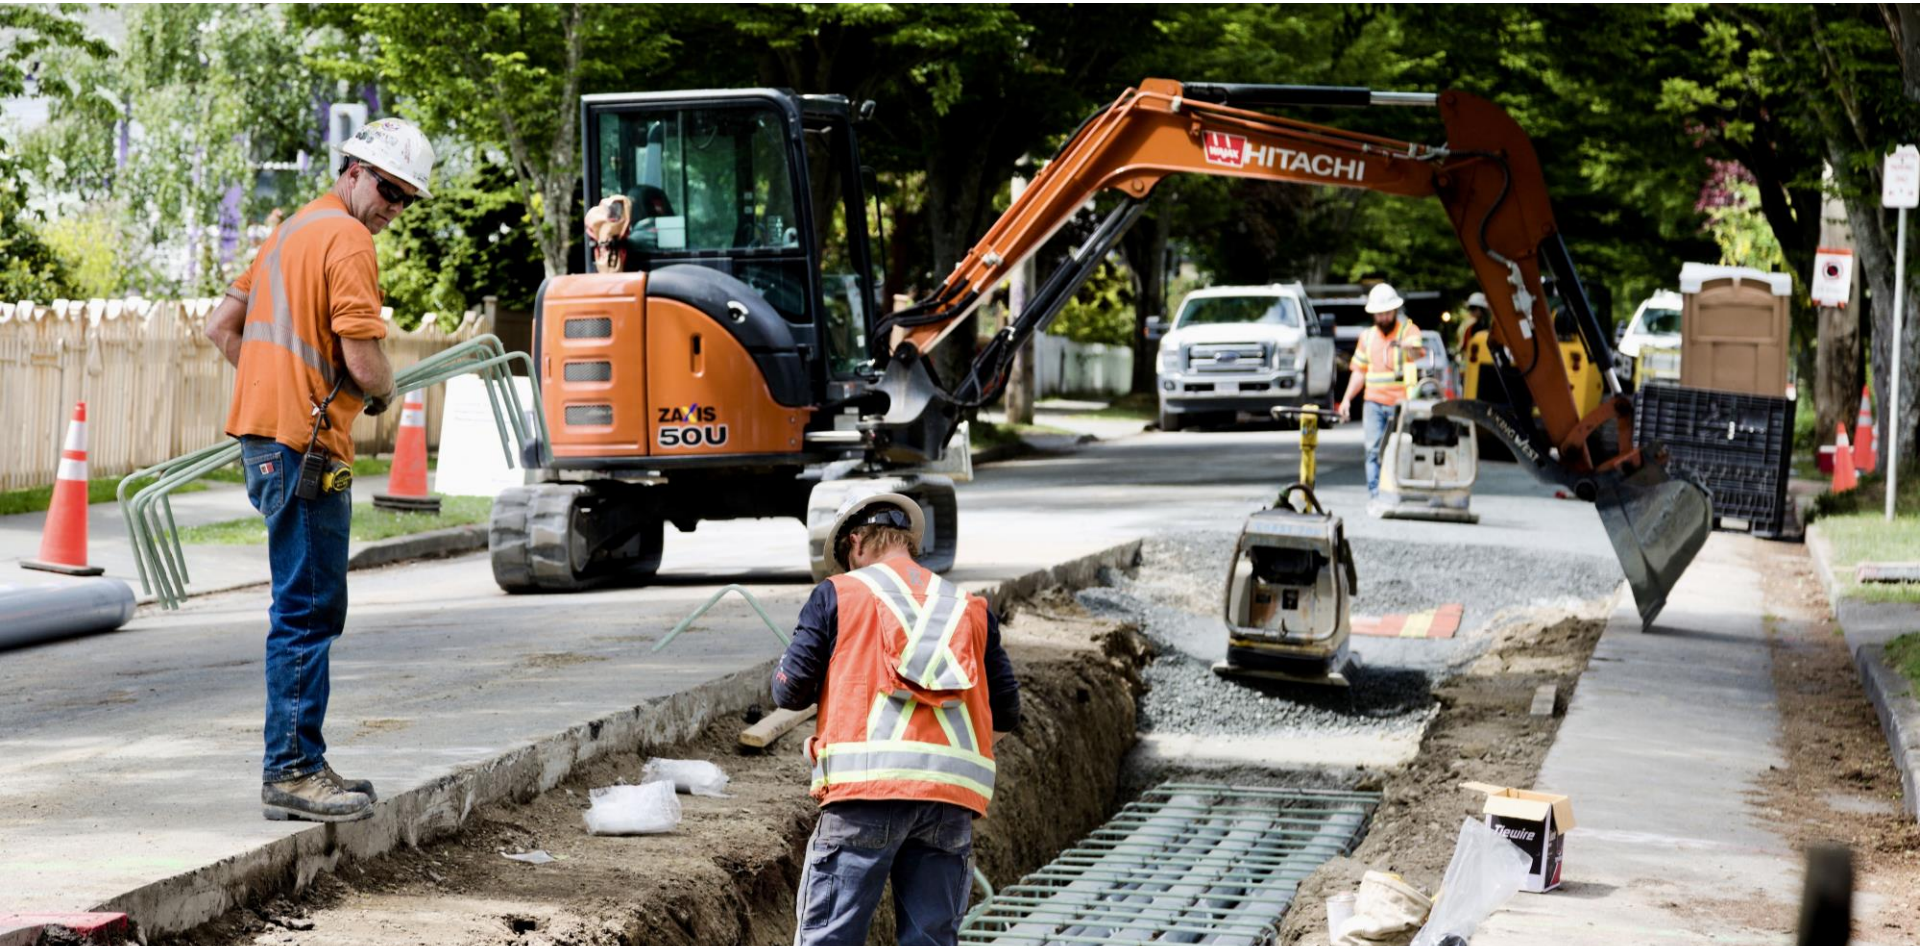
May 21: Duct bank work with the rebar placement prior to pouring concrete.

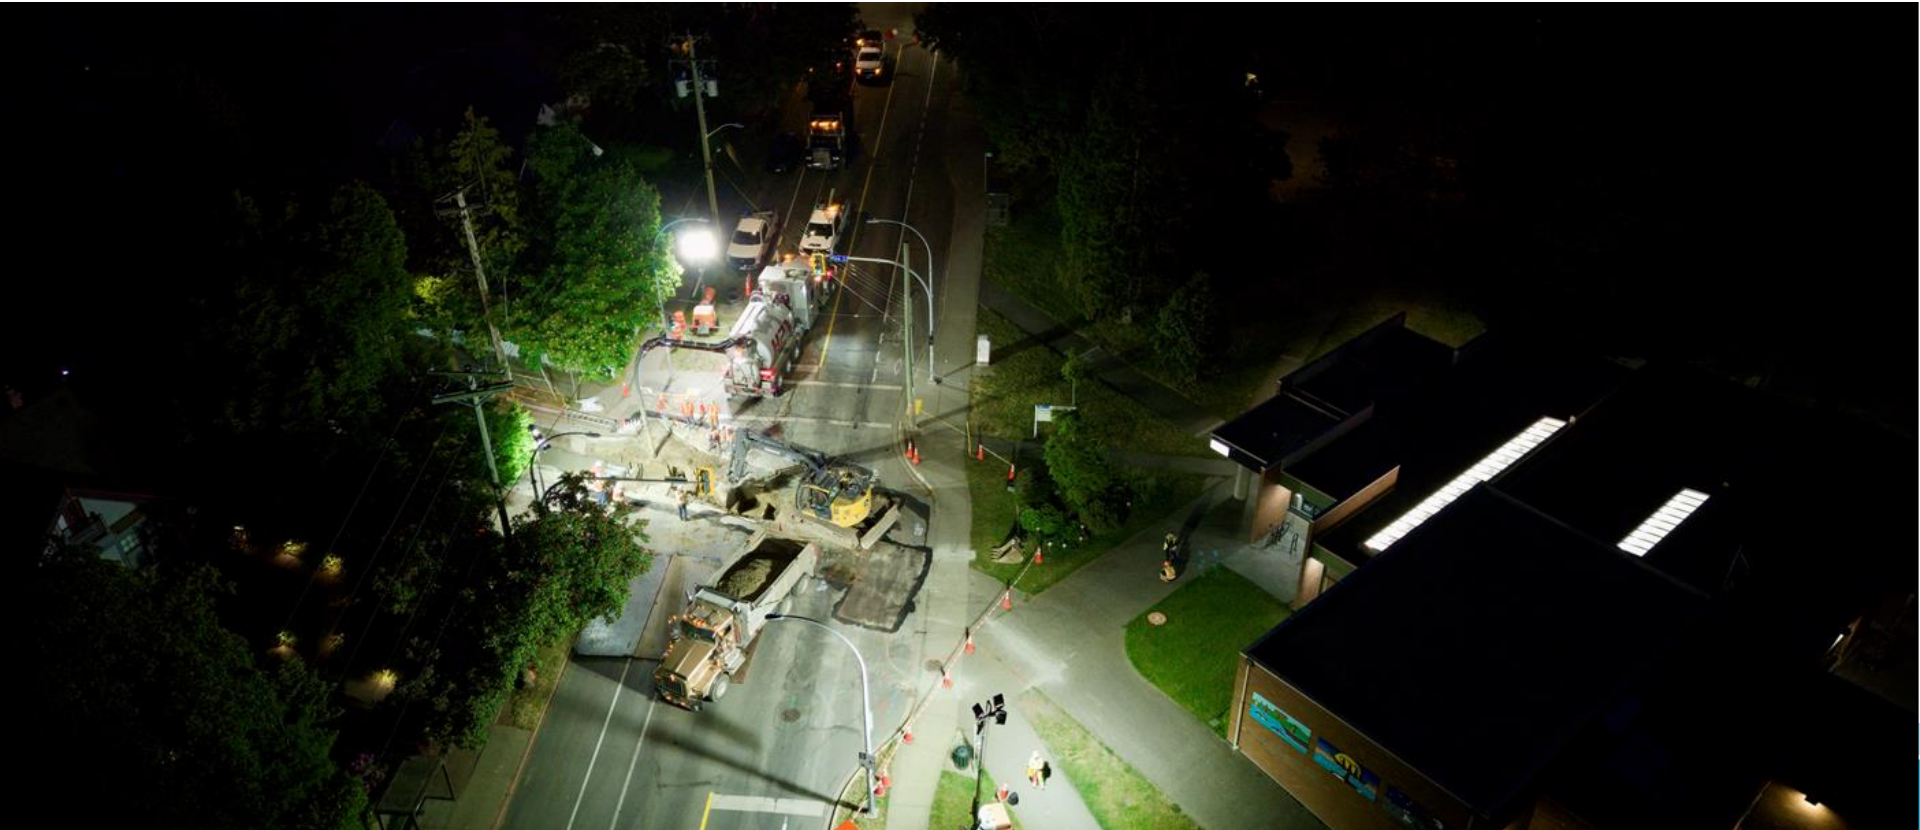
May 27: Craigflower Road crossing work.

Pine Street is on the left side and Banfield Park and the Vic West Community Centre is on the right.

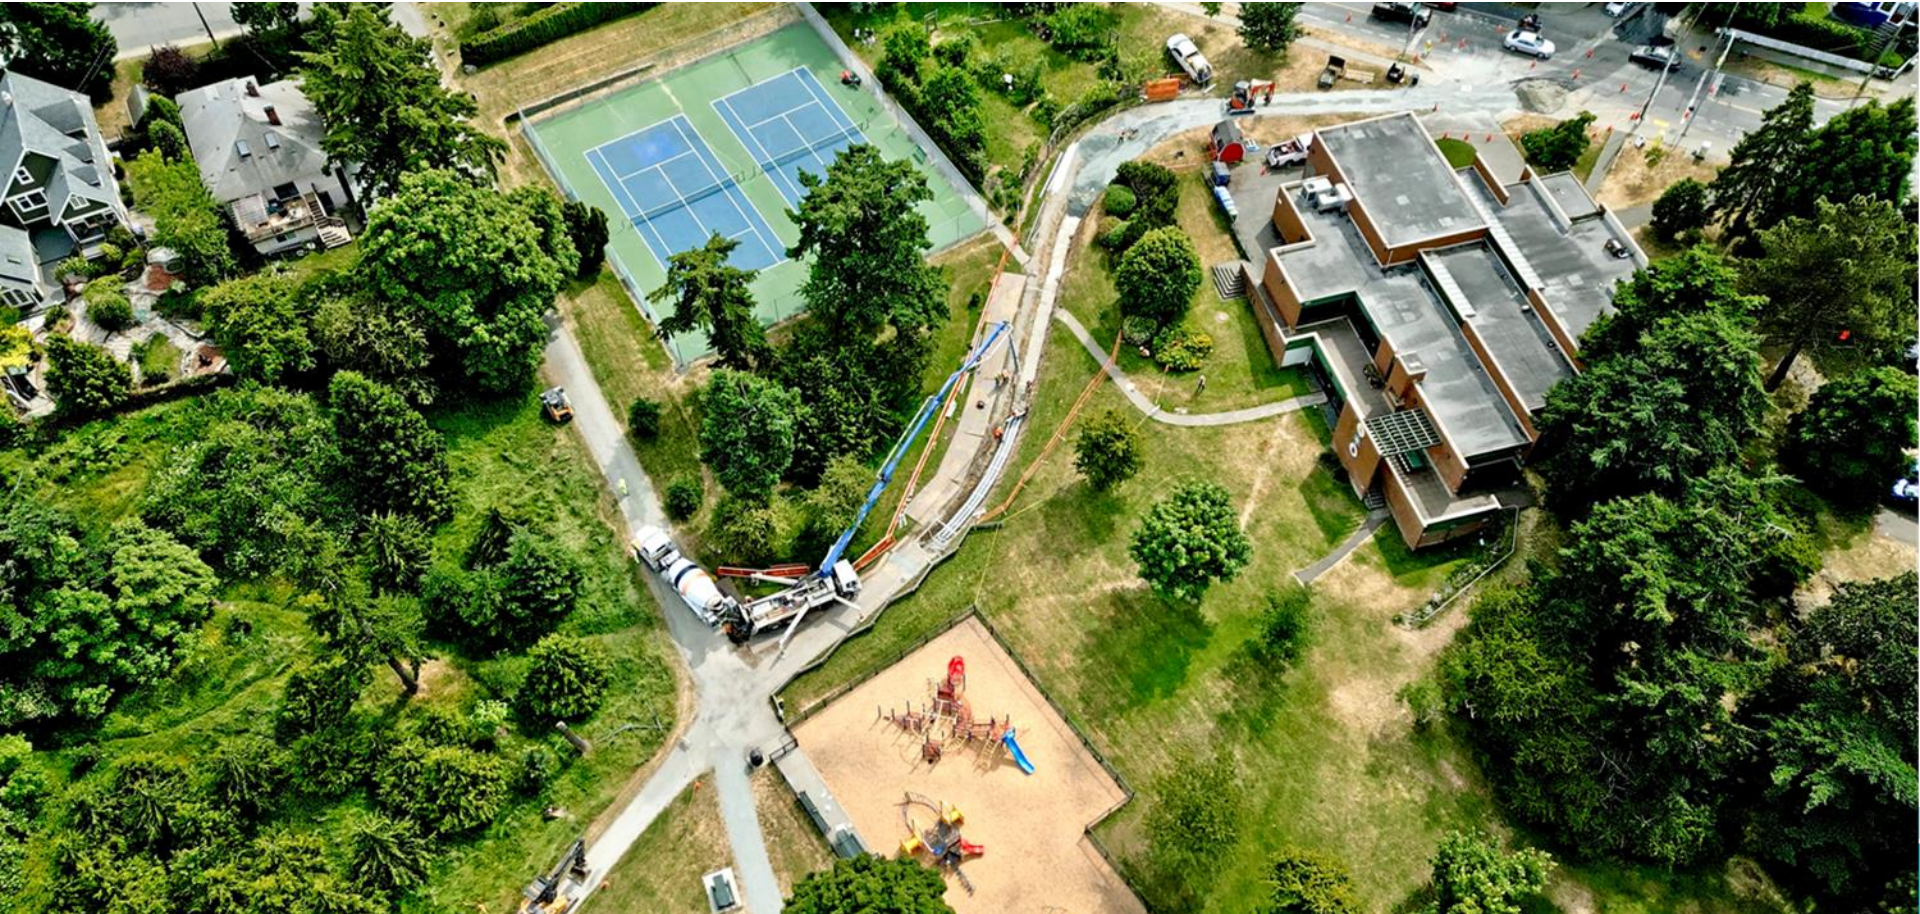
June 11: The duct bank comes down from Craigflower Road with some concrete placement work by the playground.

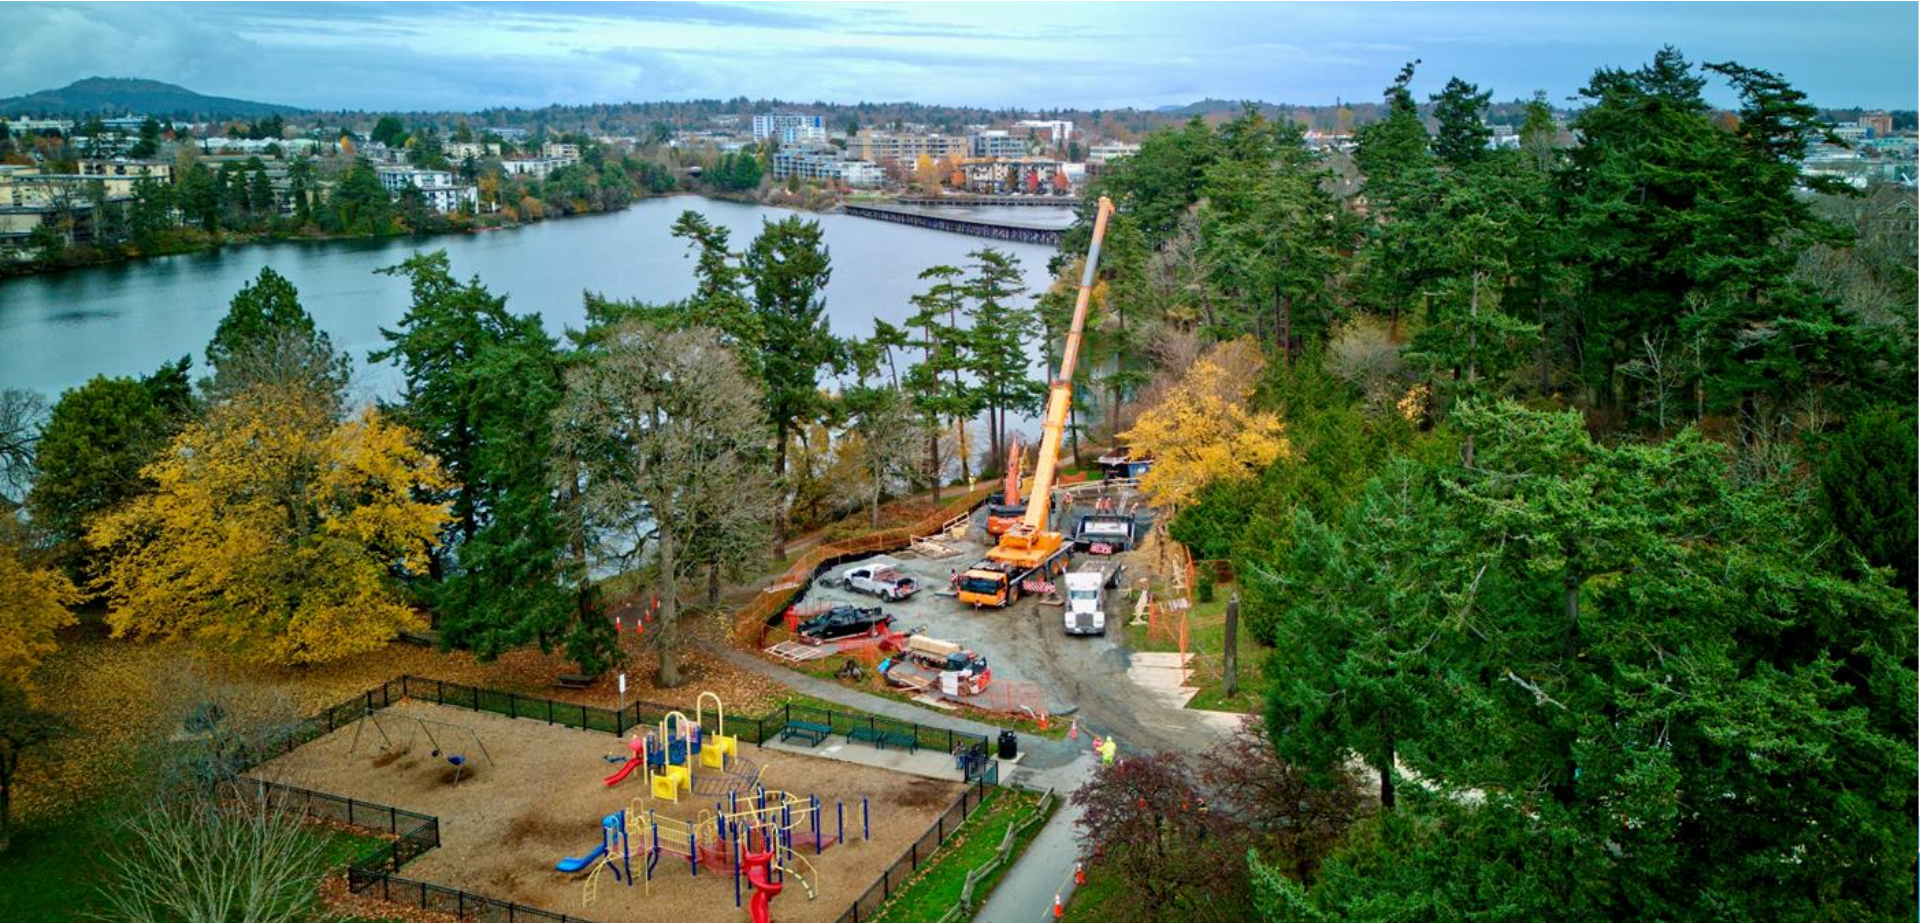
November 17: View over the work area within Banfield Park and the Gorge Waterway in the background.

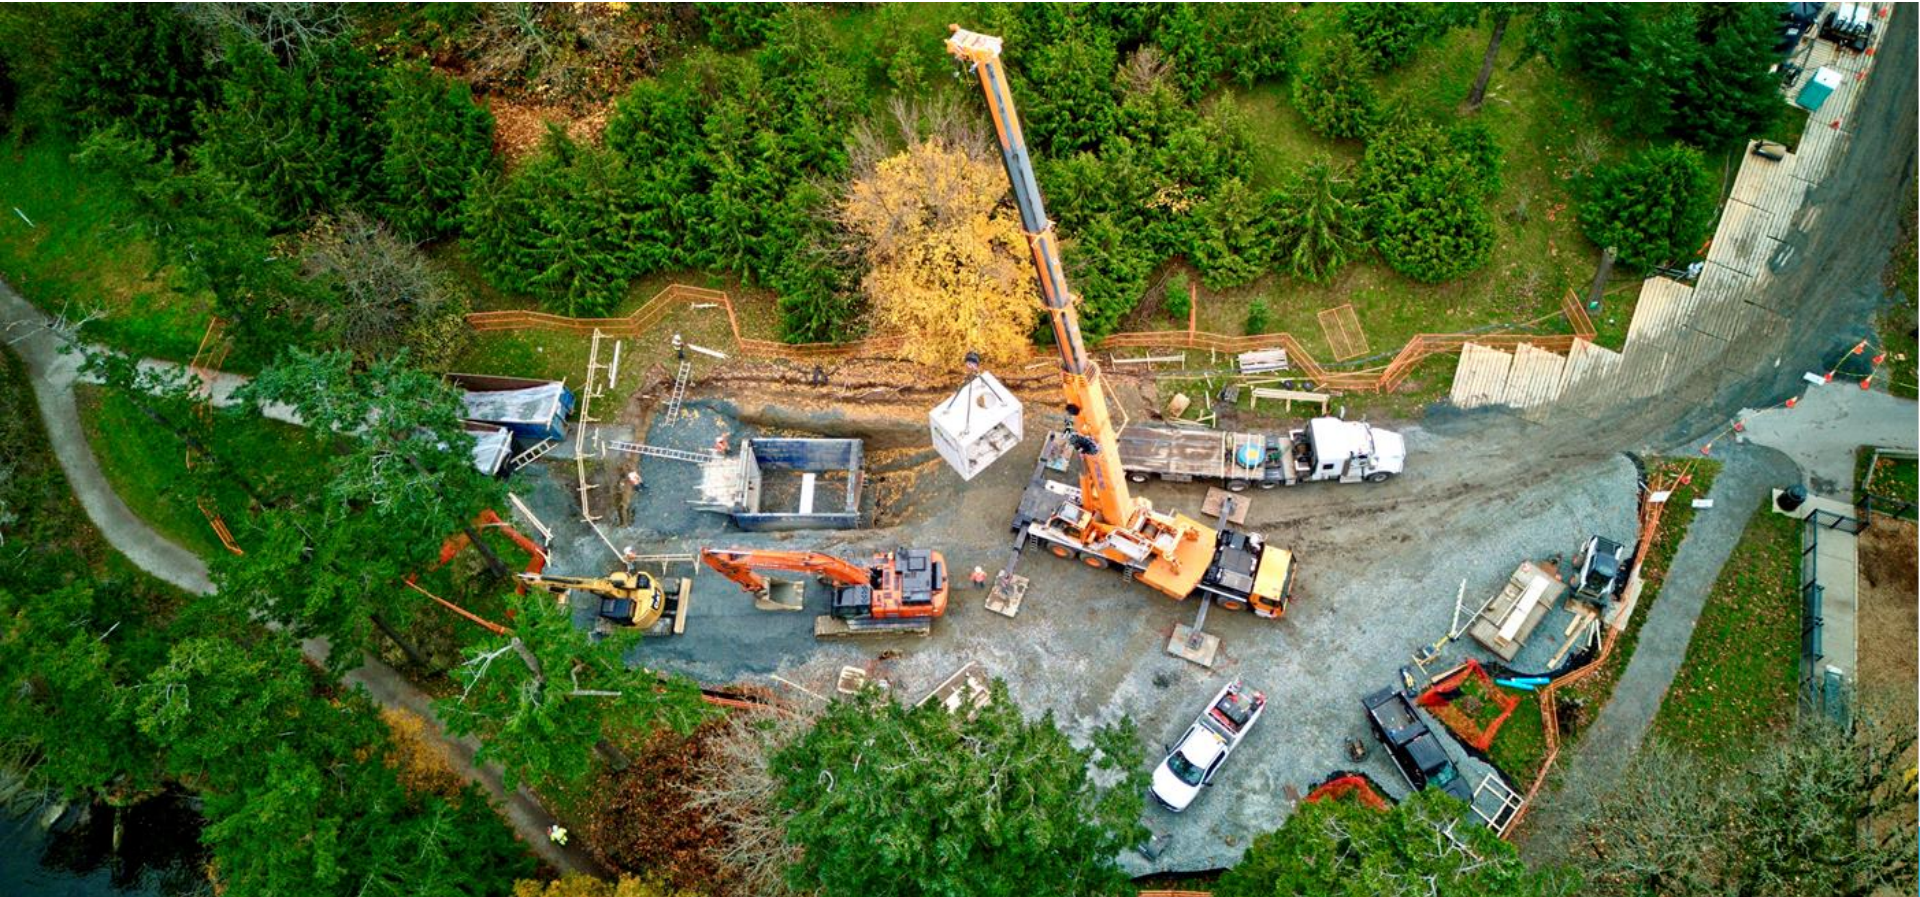
November 17: Crews moving the concrete vault section into place. A wider view of the work zone and the trail detours around it to the right, bottom, and left of the photo.

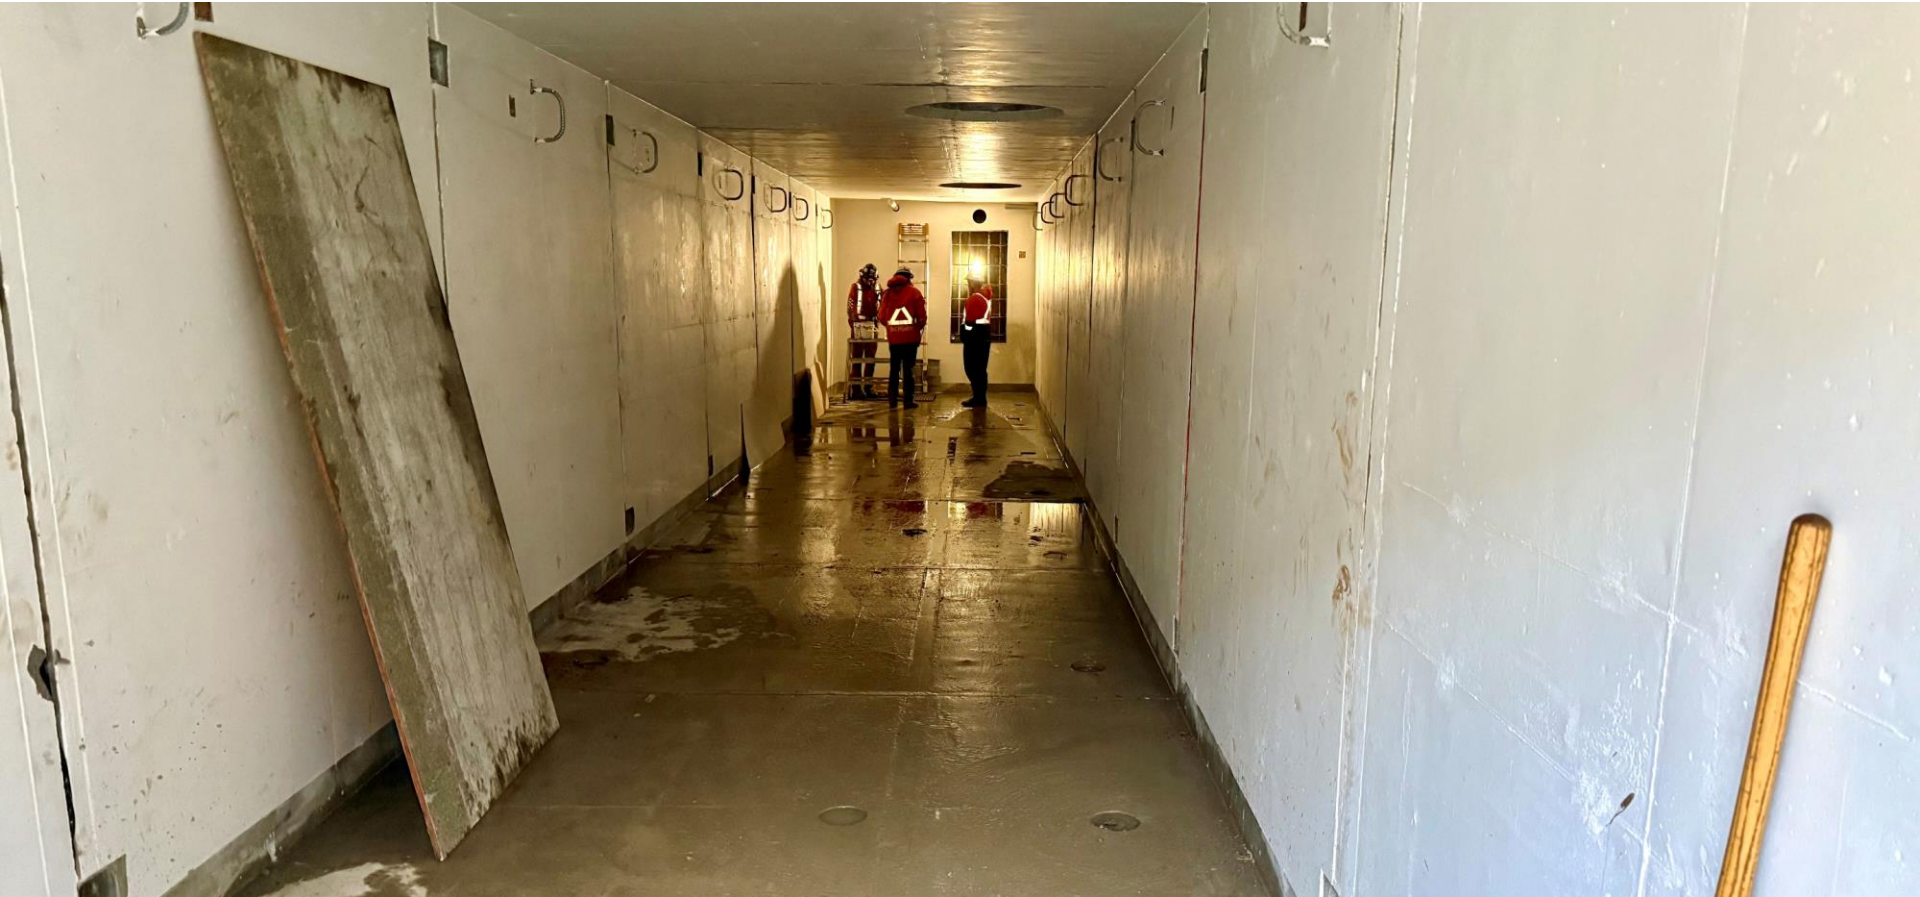
December 5: A look inside the 20-metre-long concrete vault. These vaults are where the duct bank will enter and provide crews with access to pull in and splice the power cables together.

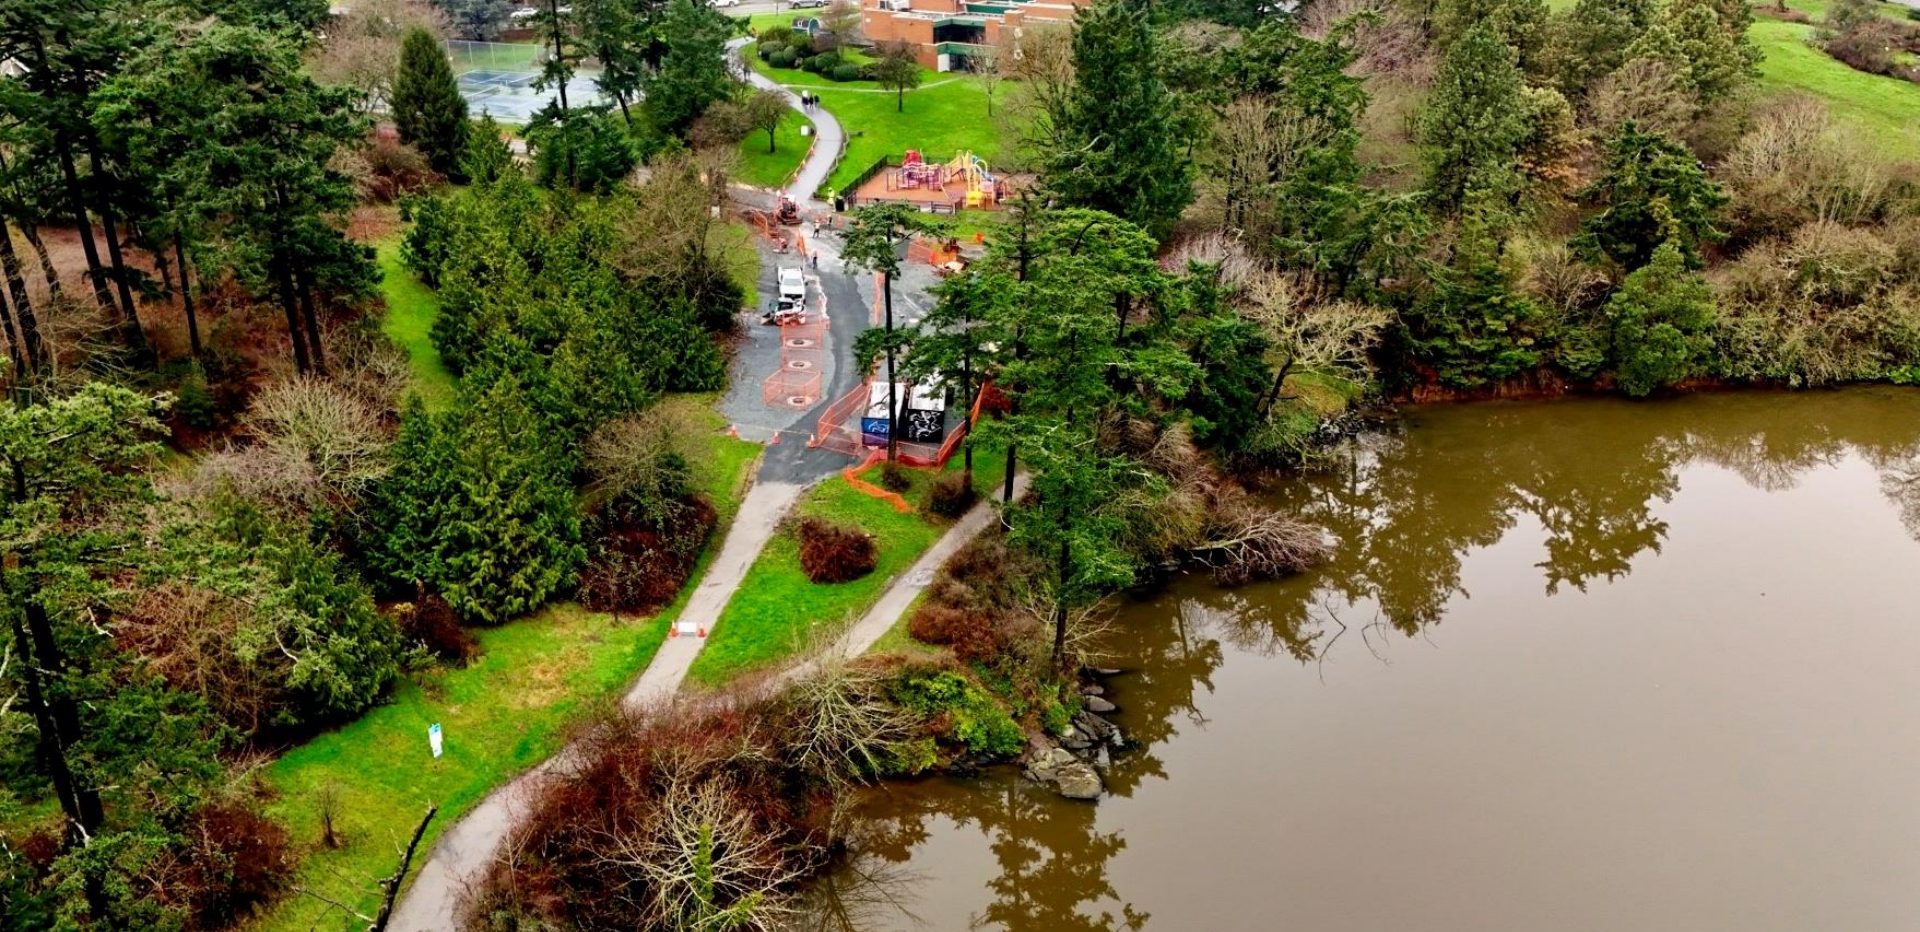
January 13: View of the work area within the park.

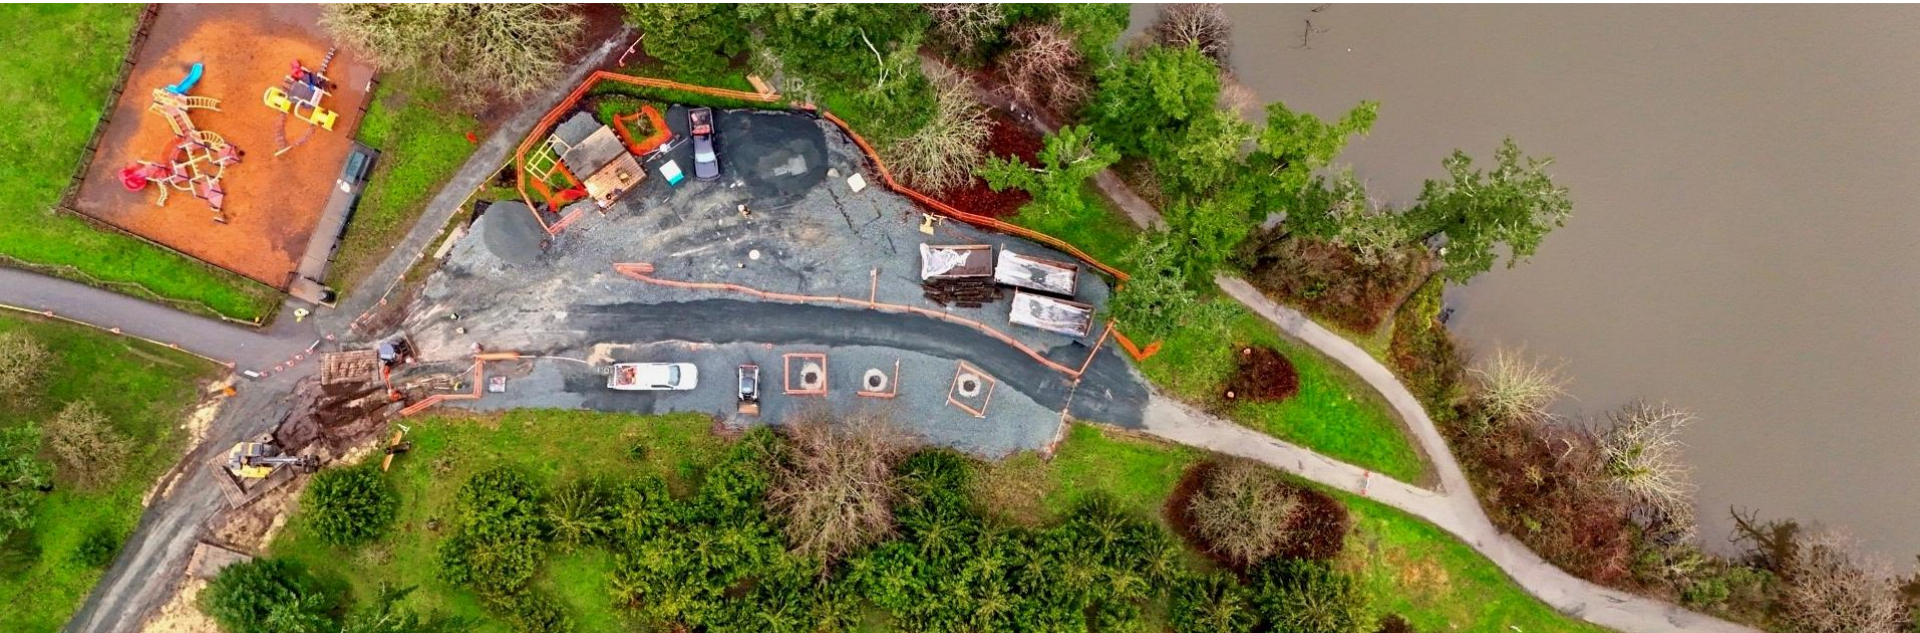
January 13: Drone view of the work site. The general work plan for 2026/2027 for the park includes:

- January: Power conduit from Raynor Street to the concrete vault.
- January: Tree and brush removal within the riparian area prior to bird nesting season.
- February: Anchor and duct bank work from the concrete vault to the 1-2 metres away from the gravel path by the foreshore.
- June: Cable pulling through the vault and conduits to the Esquimalt Substation.
- June-September: Gorge Waterway marine work to place conduit about 1.5 metres under the seabed.
- October: Cable pulling through the vaults and conduits to Viaduct Park.
- October-November: Banfield Park remediation and restoration of the work area to install the new duct bank and concrete vault.
- December thru 2027: Staged construction of saltmarsh within the foreshore area for fish habitat off-setting.

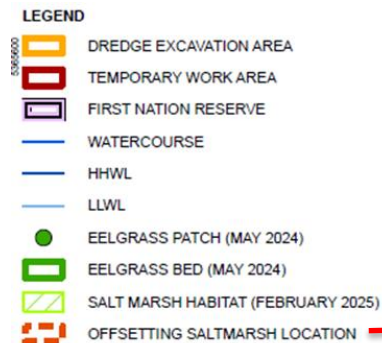
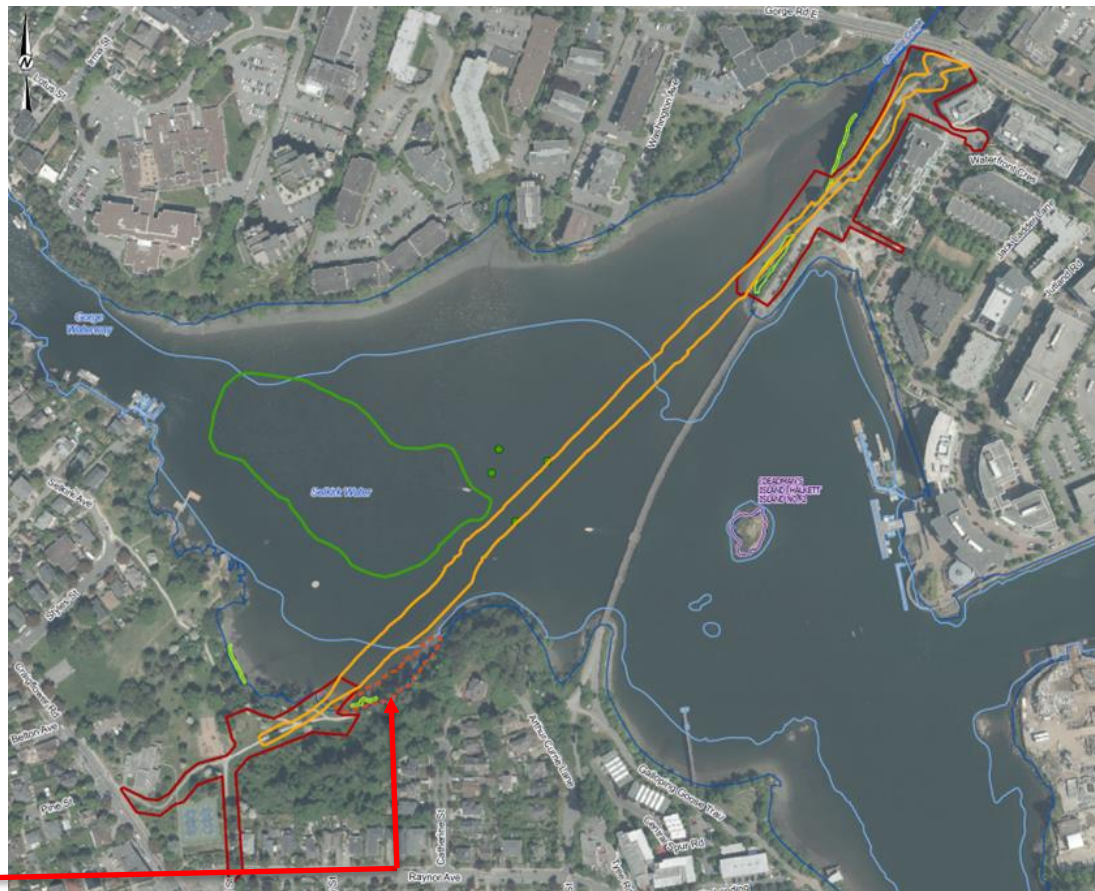
In early November 2025, the project received approval from Fisheries and Oceans Canada for the Fisheries Act Authorization to place duct bank within the Gorge Waterway and foreshore areas. The work will take place during the summer 2026 fisheries work window. This includes about a 1.5 metre deep and ~4-metre-wide sloped trench excavated within the marine bottom to then place the conduit for the cables. About 20,000 cubic metres of removed material will be replaced with clean material.

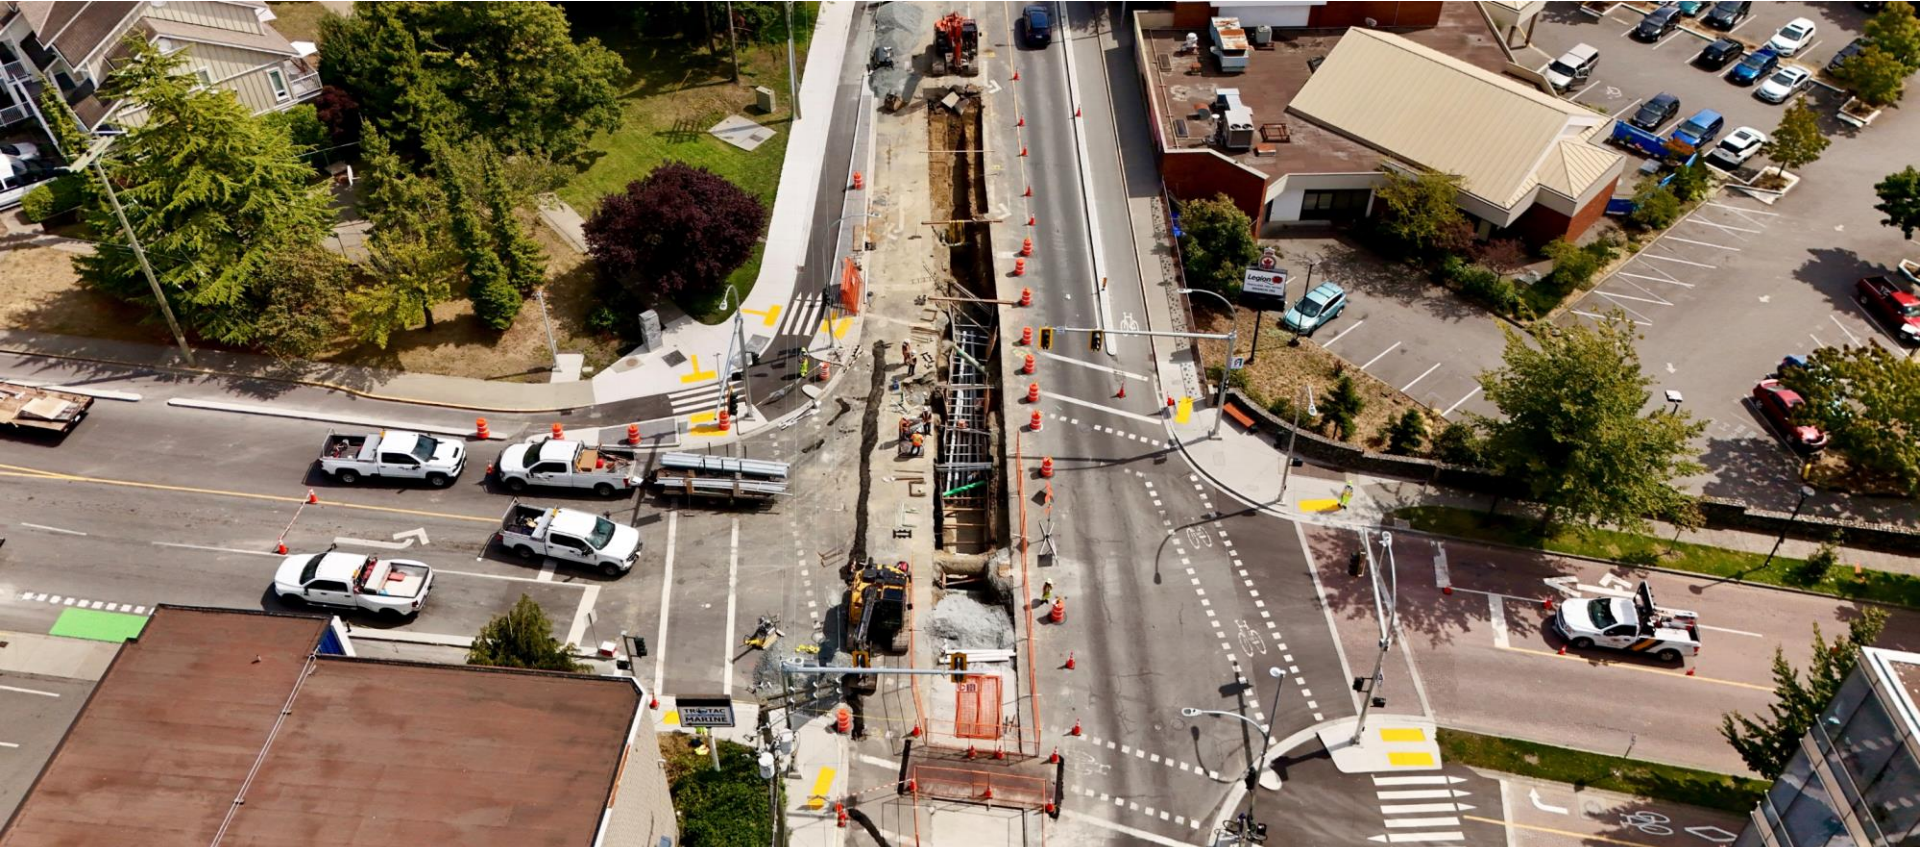
August 19: Duct bank work moving through the intersection and beginning to move eastward down Gorge Road.
