Victoria to Esquimalt Cable Replacement Project – Update Presentation

Burnside-Gorge Community Association

Project Overview

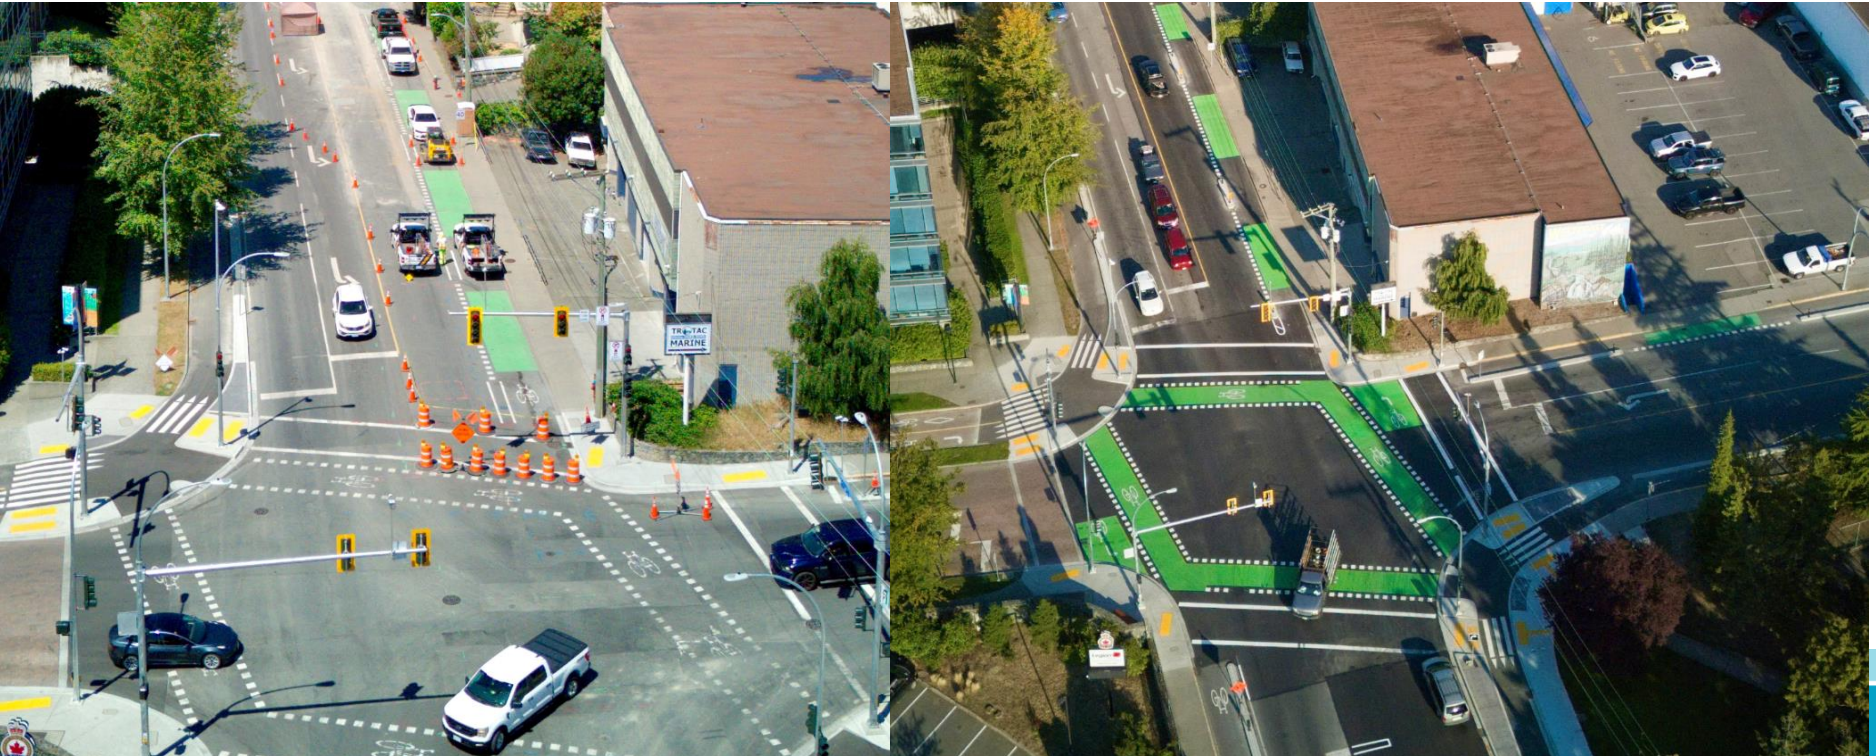
July 30 photo on left and September 16 photo on right shows the before and after of the intersection, looking west up Gorge Road. In coordination with the City of Victoria, it was agreed BC Hydro would do final paving and line painting of the entire Jutland intersection along with installation of concrete bike lane curbs along the westbound Gorge Road lane.

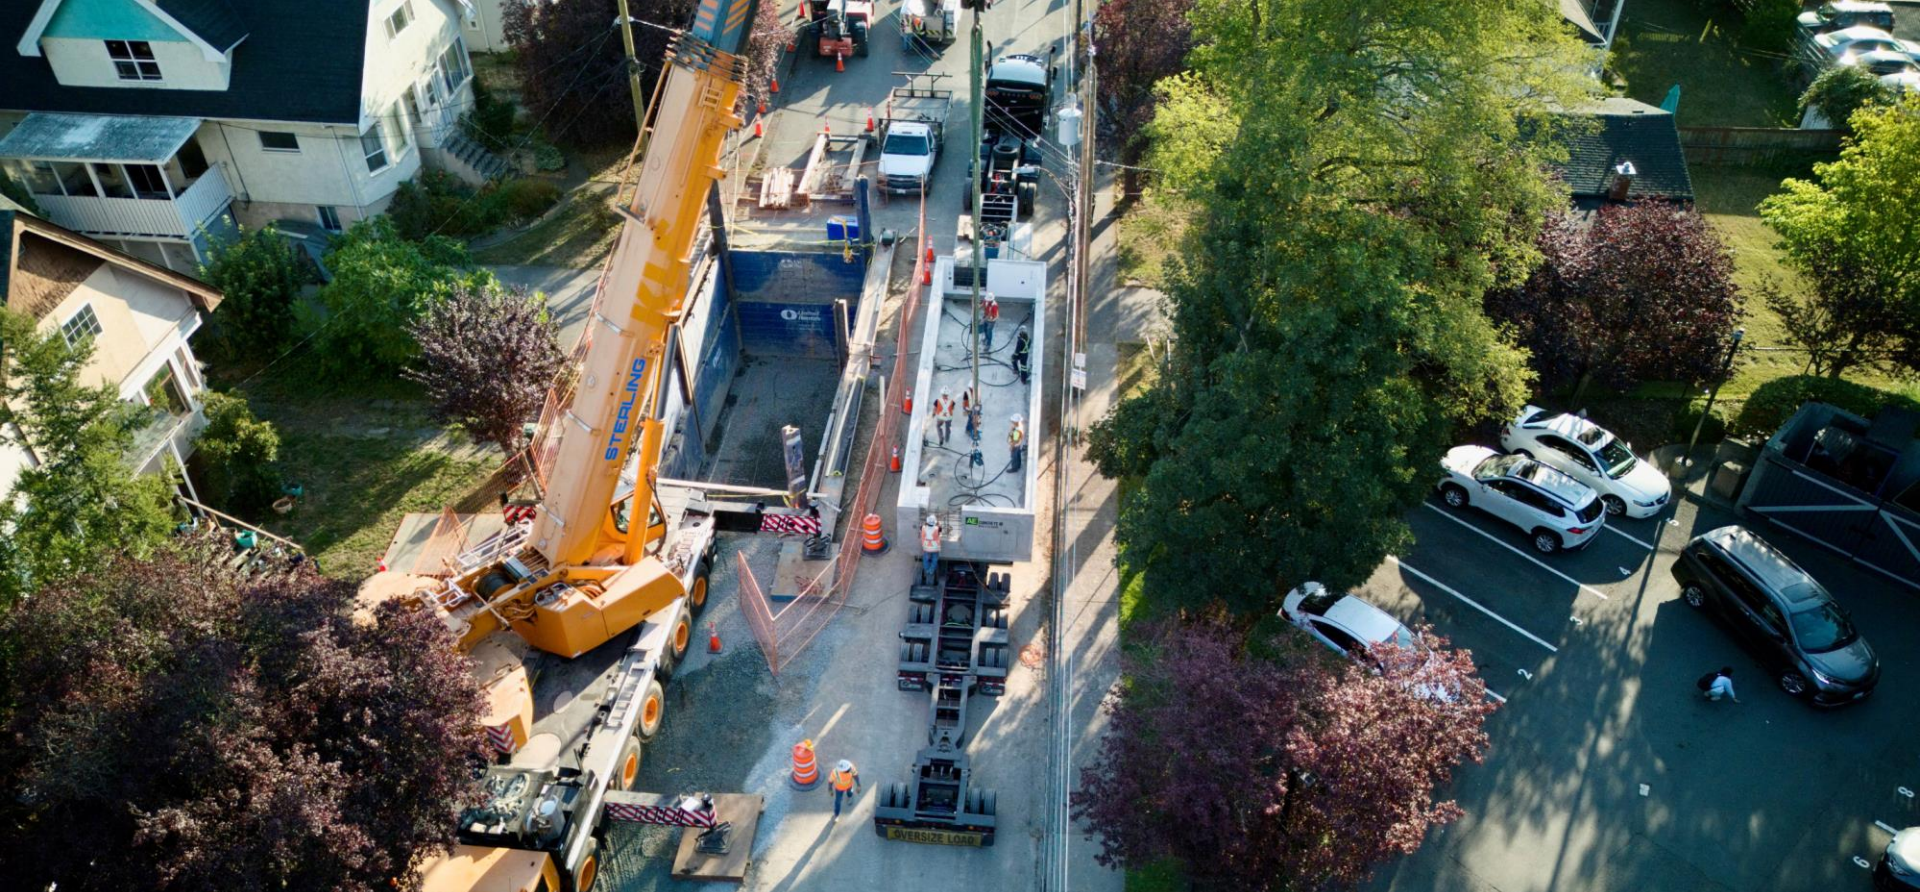
September 16: Crews making final checks to ensure a safe and secure lift of the lower section of the concrete vault. The first concrete vault for the project was successfully placed on Dunedin Street.

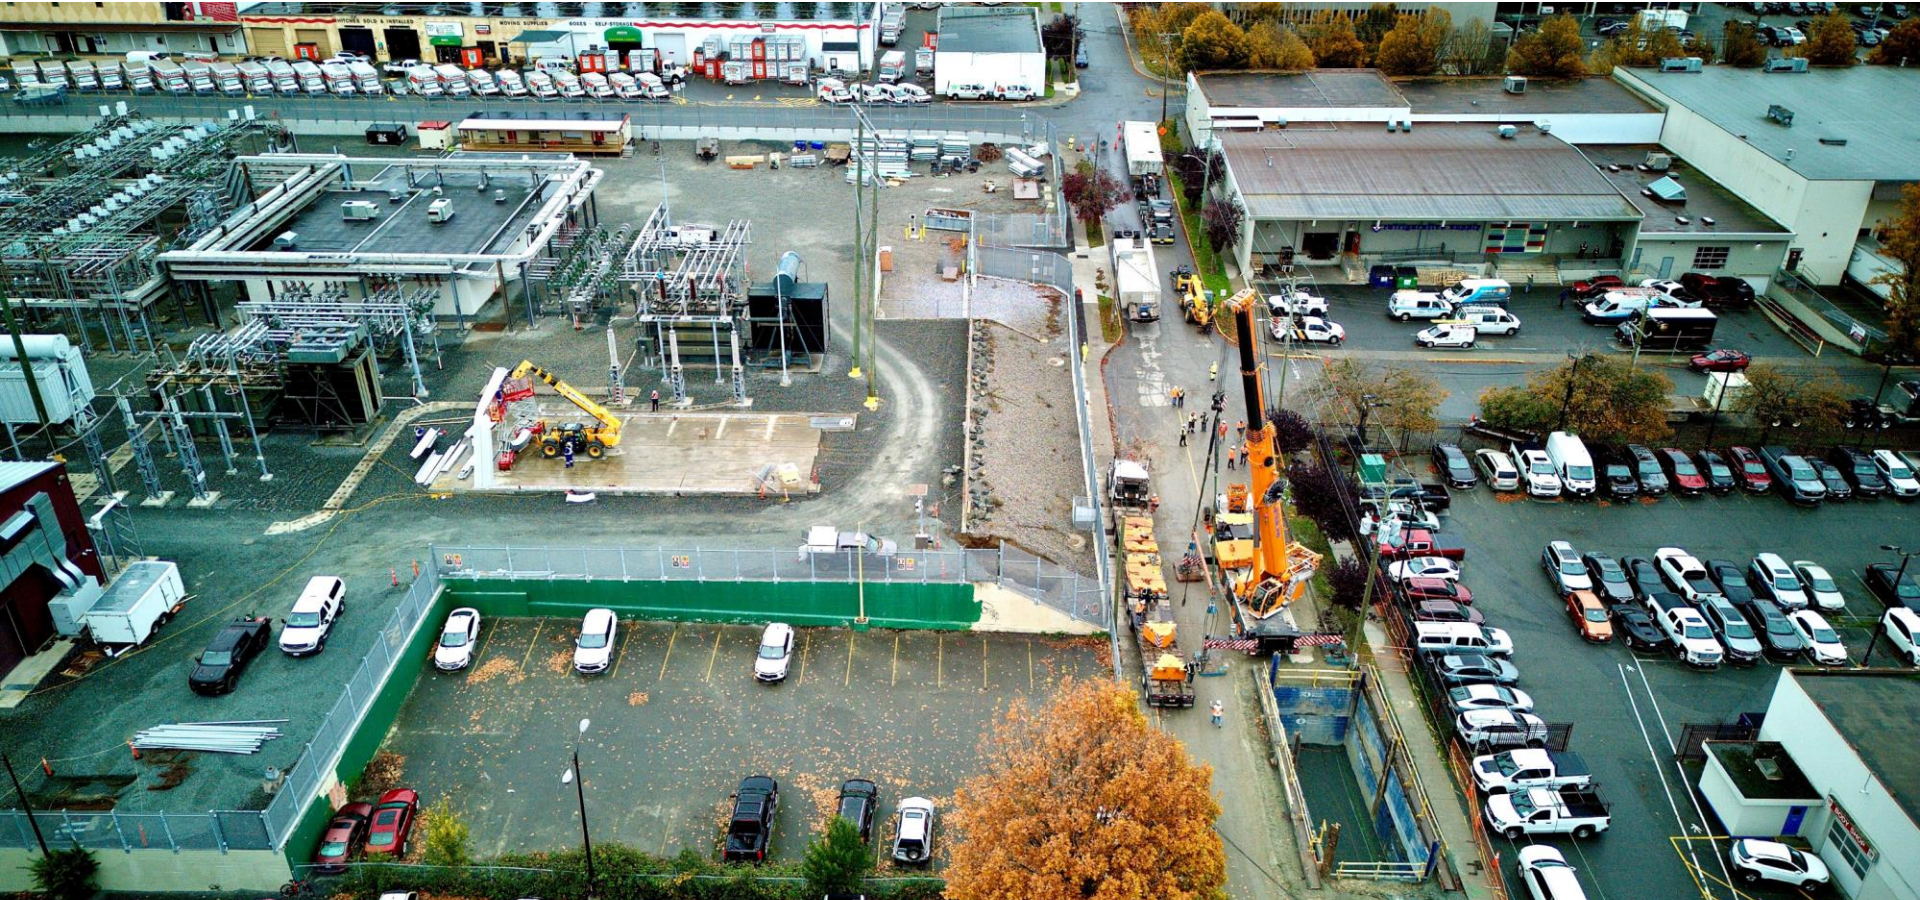
October 28: Crews getting ready to install the third and final concrete vault along city streets (a vault will be placed in Banfield Park and in Viaduct Park). The two sections of the concrete vault are shown in the upper part of Topaz Avenue.

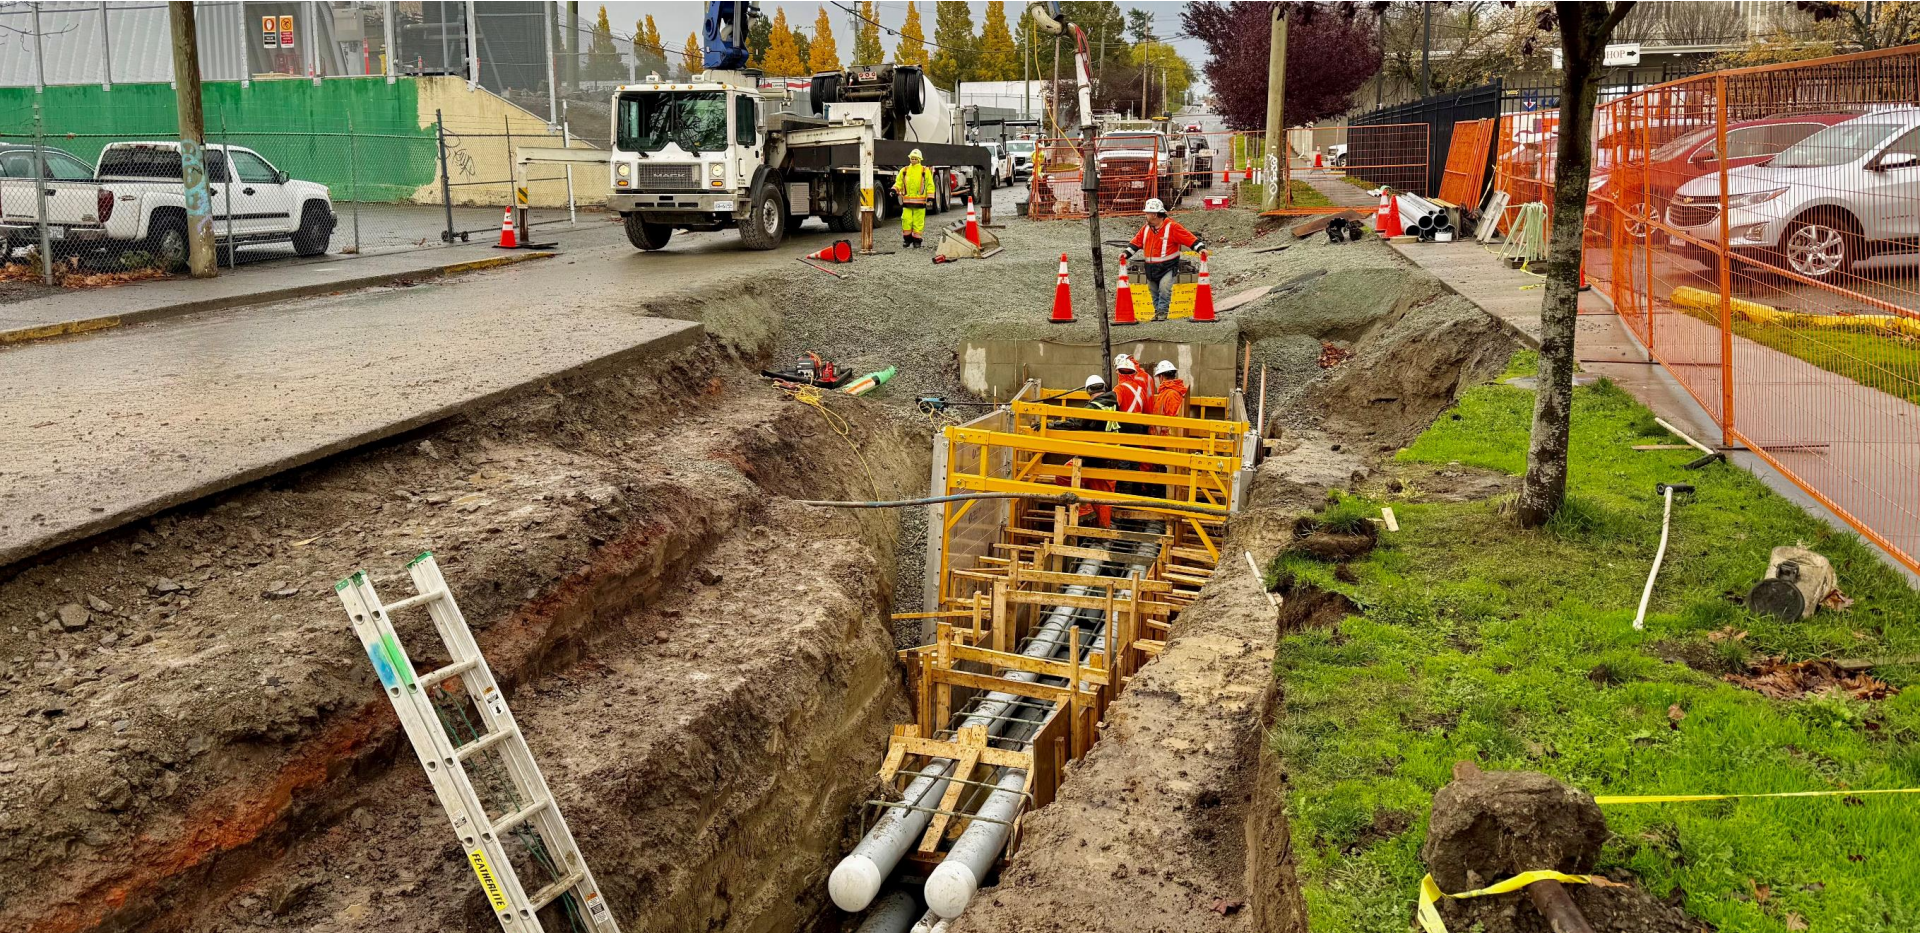
November 6: Placing concrete over the conduit connected to the concrete vault.

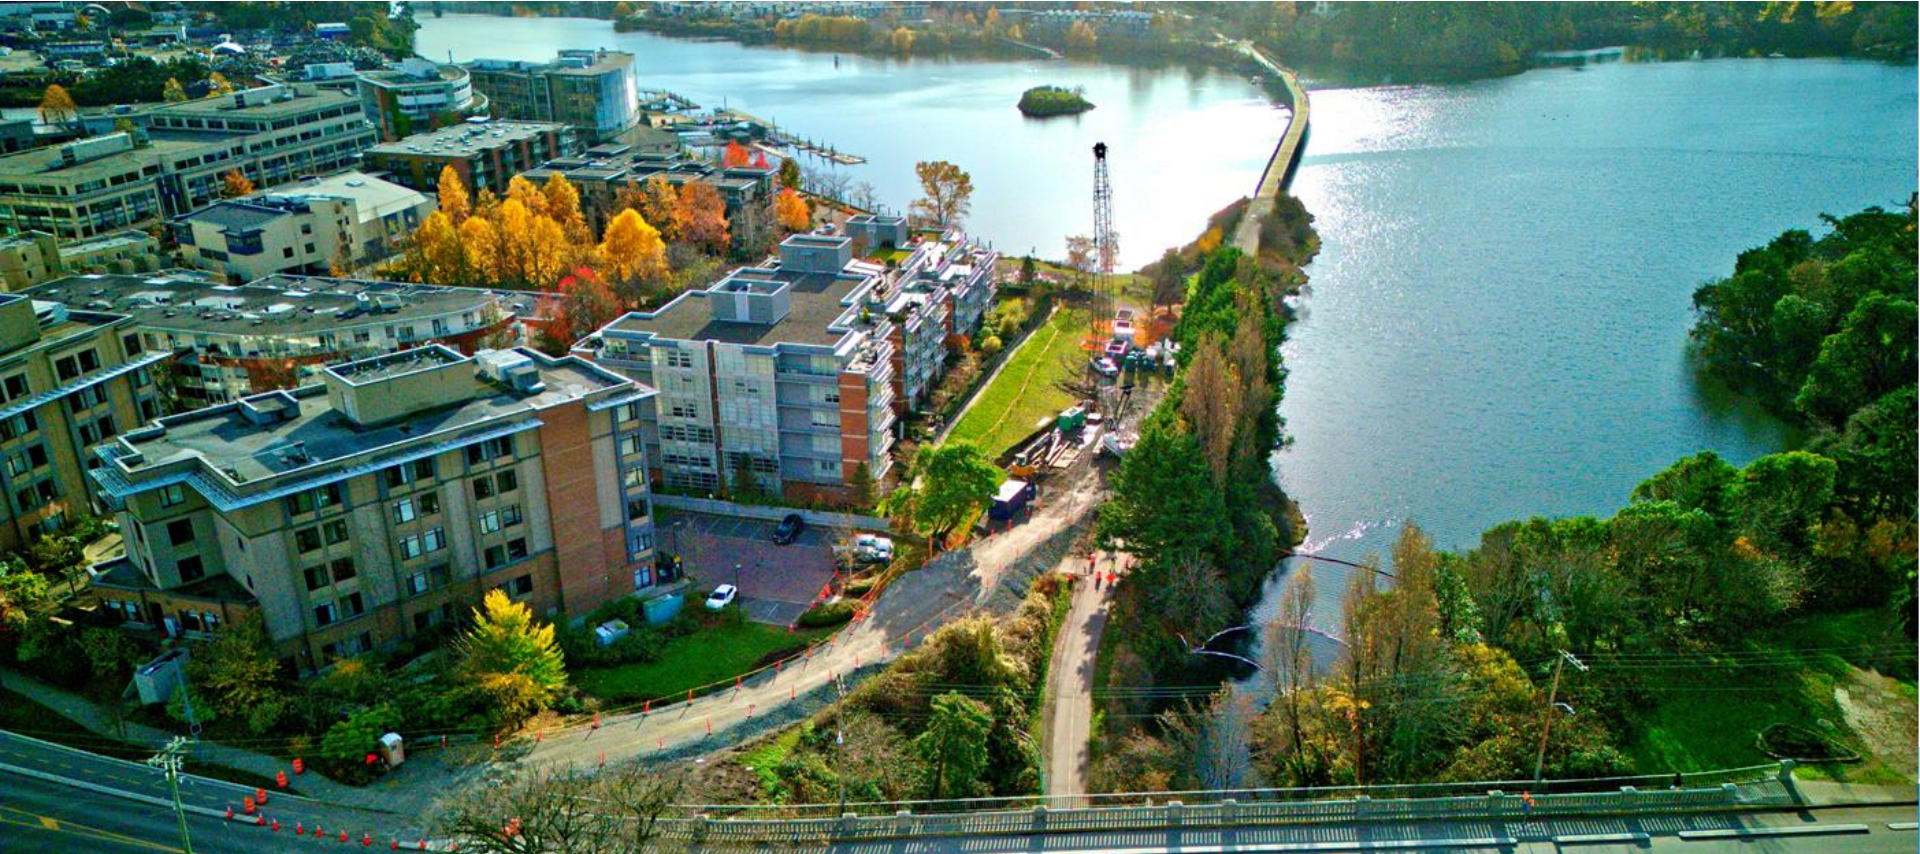
November 17: Panoramic view of Viaduct Park with the construction access road coming down from Gorge Road at the bottom left. Crews moved in the large crane on this day and began to setup the work area.

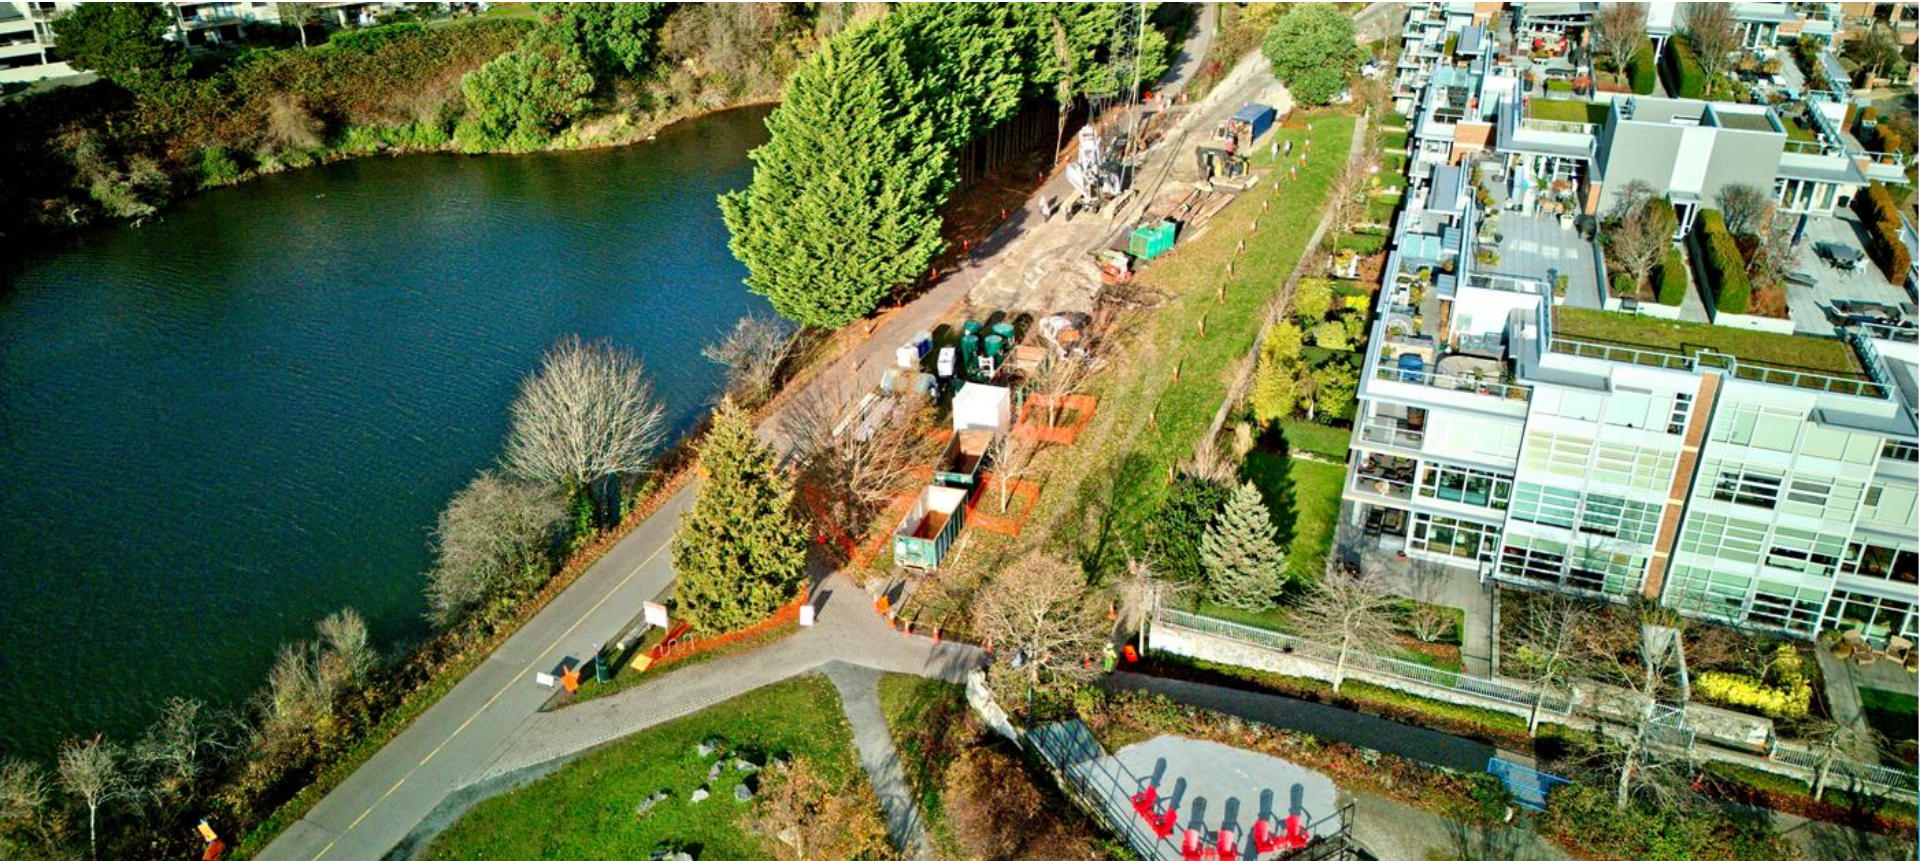
November 17: A different vantage of the work area within Viaduct Park. At the bottom of the photo, the temporary detour for the Galloping Goose Trail that follows a sidewalk to the south side of the condominium building.

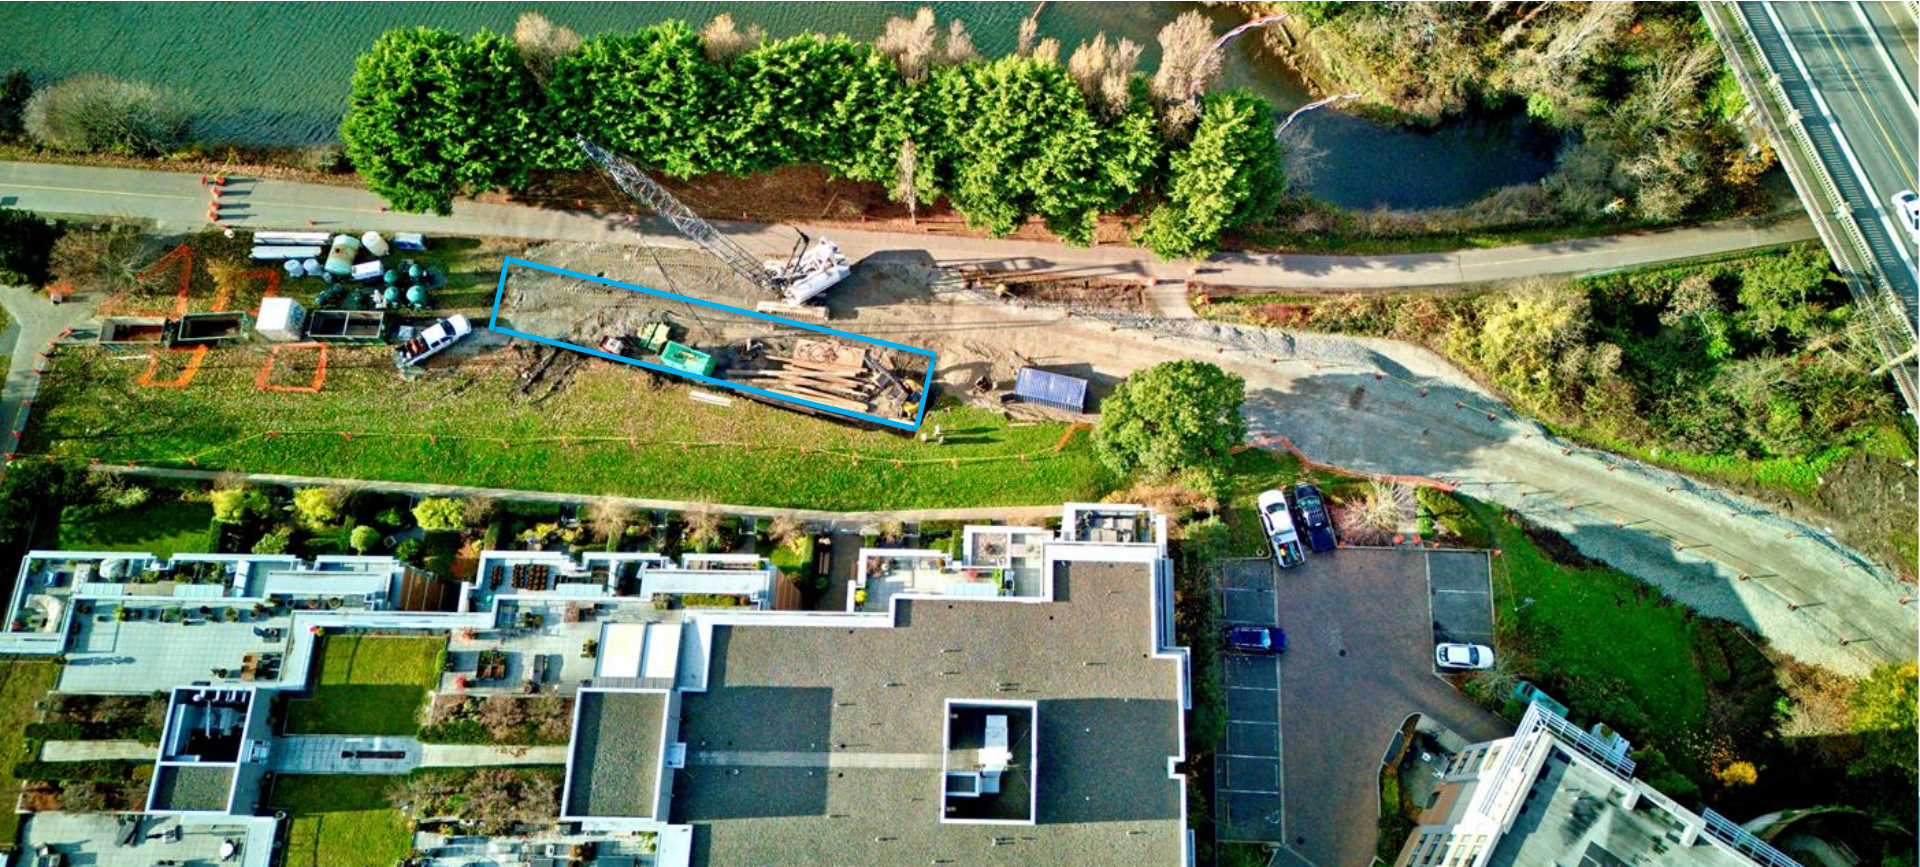
November 17: Crews, equipment, and the crane within the park. The steel piles for the shoring work for the concrete vault and area on the water side of the vault is shown by the blue elongated rectangle.

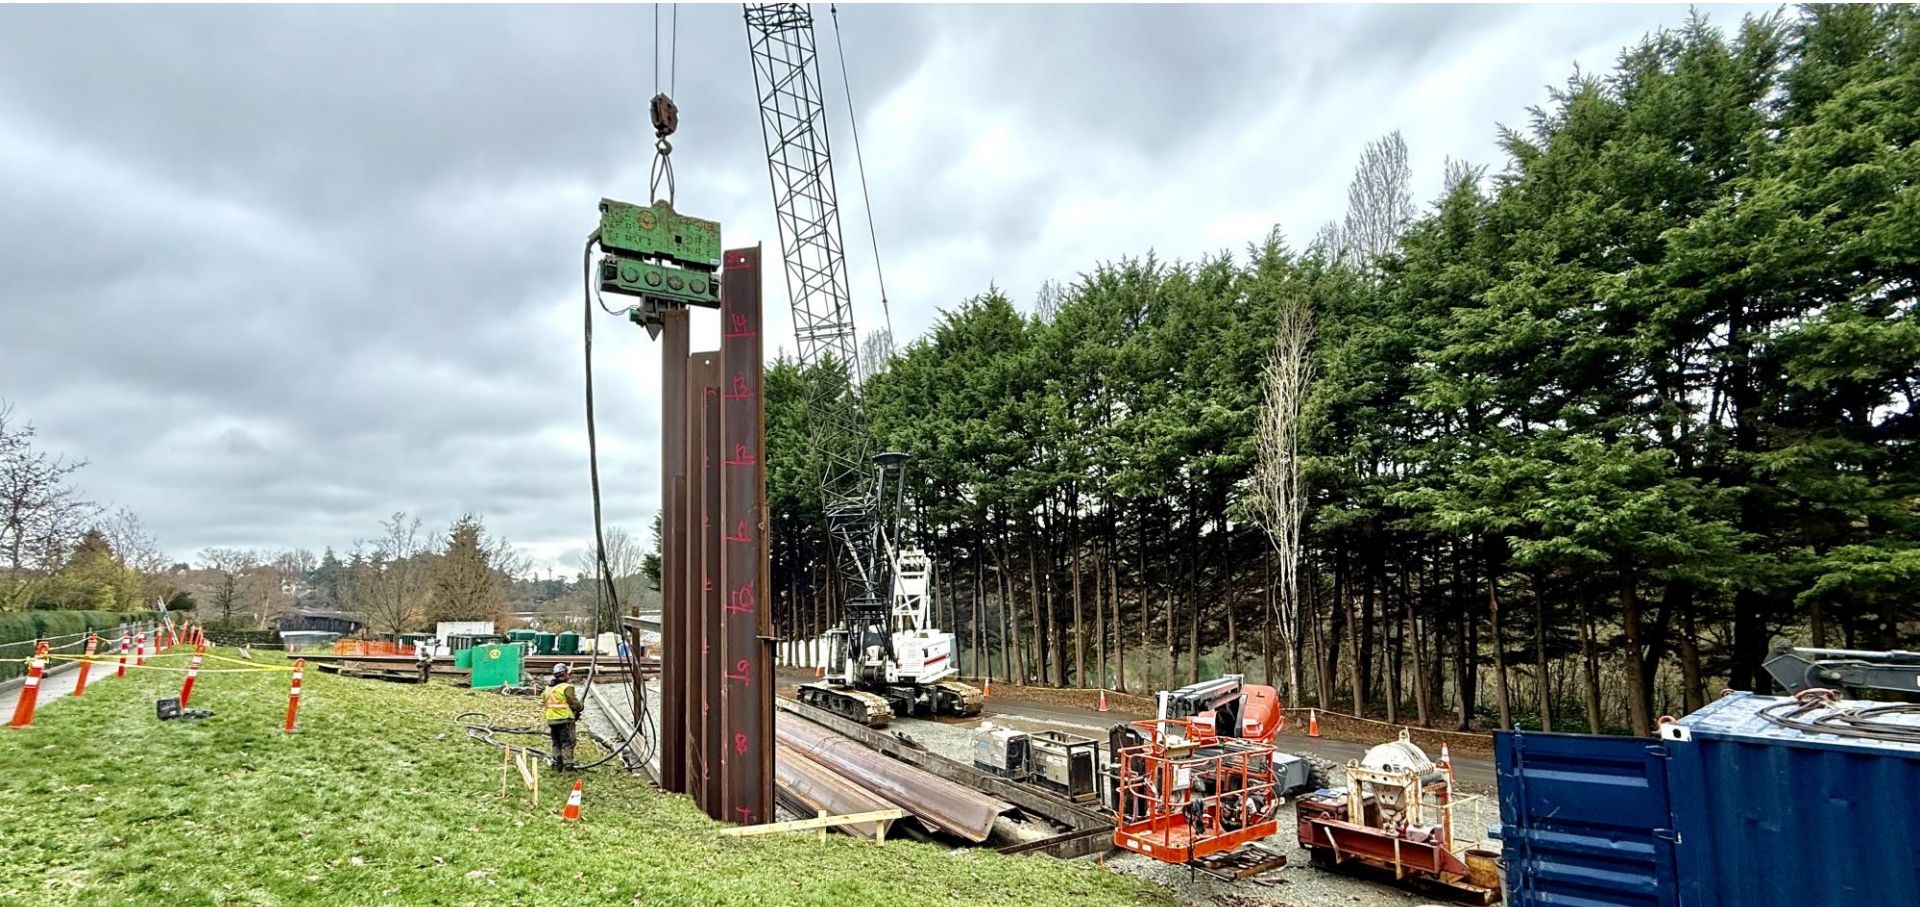
November 26: Sheet pile work.

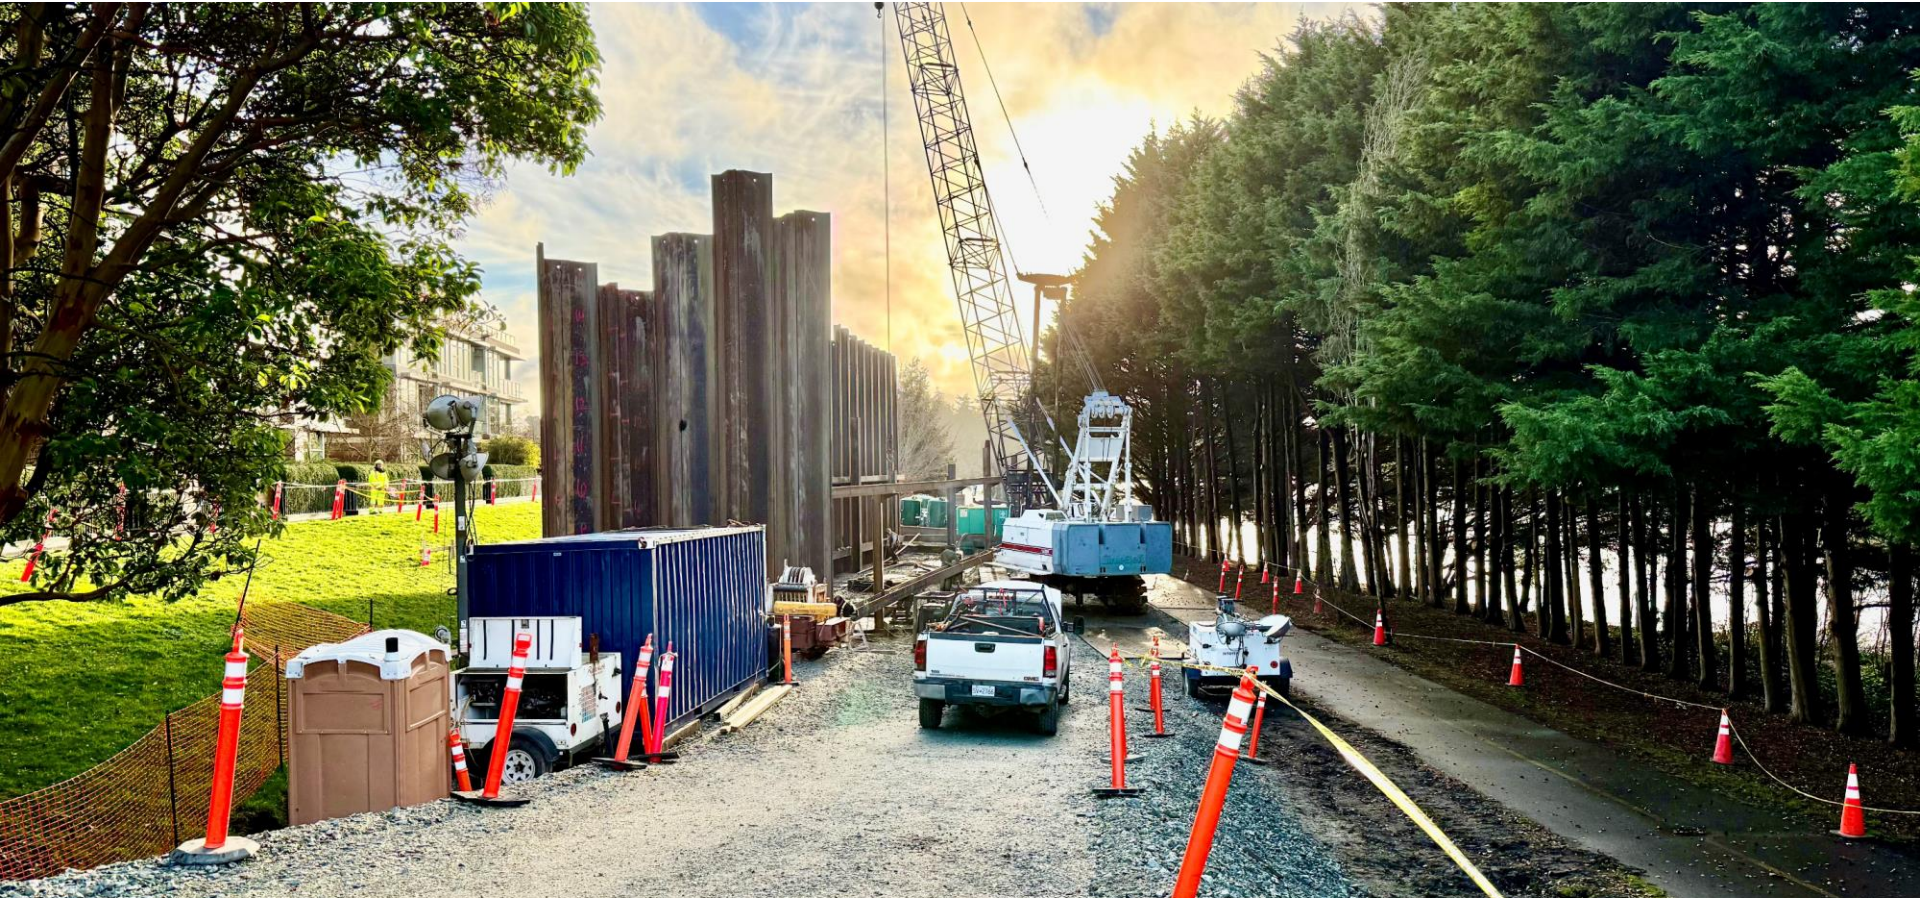
December 5: The sheet pile work from the new access road that comes down from Gorge Road. Our sheet pile contractor is Heavy Metal Marine.

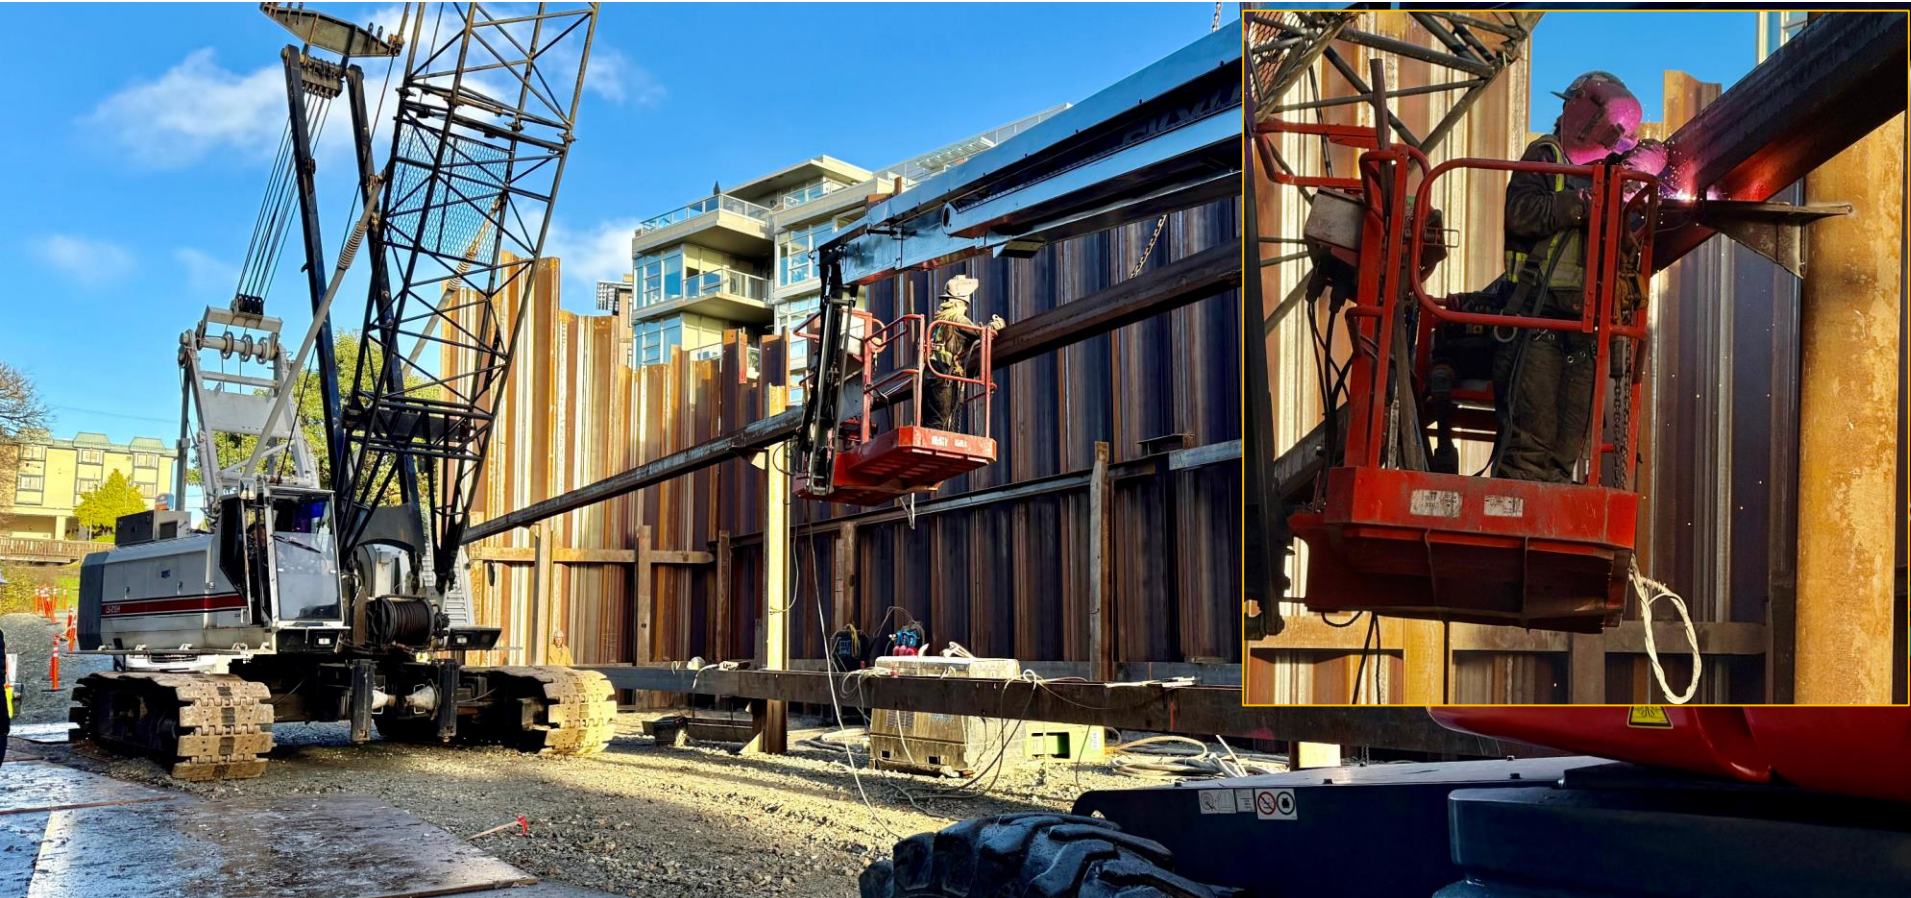
December 5: Work on the frame for the sheet pile placements. The inset photo shows some of the ongoing welding work to ensure each sheet is lined up and is guided into the ground to provide one cohesive wall to keep out groundwater during soil excavation.

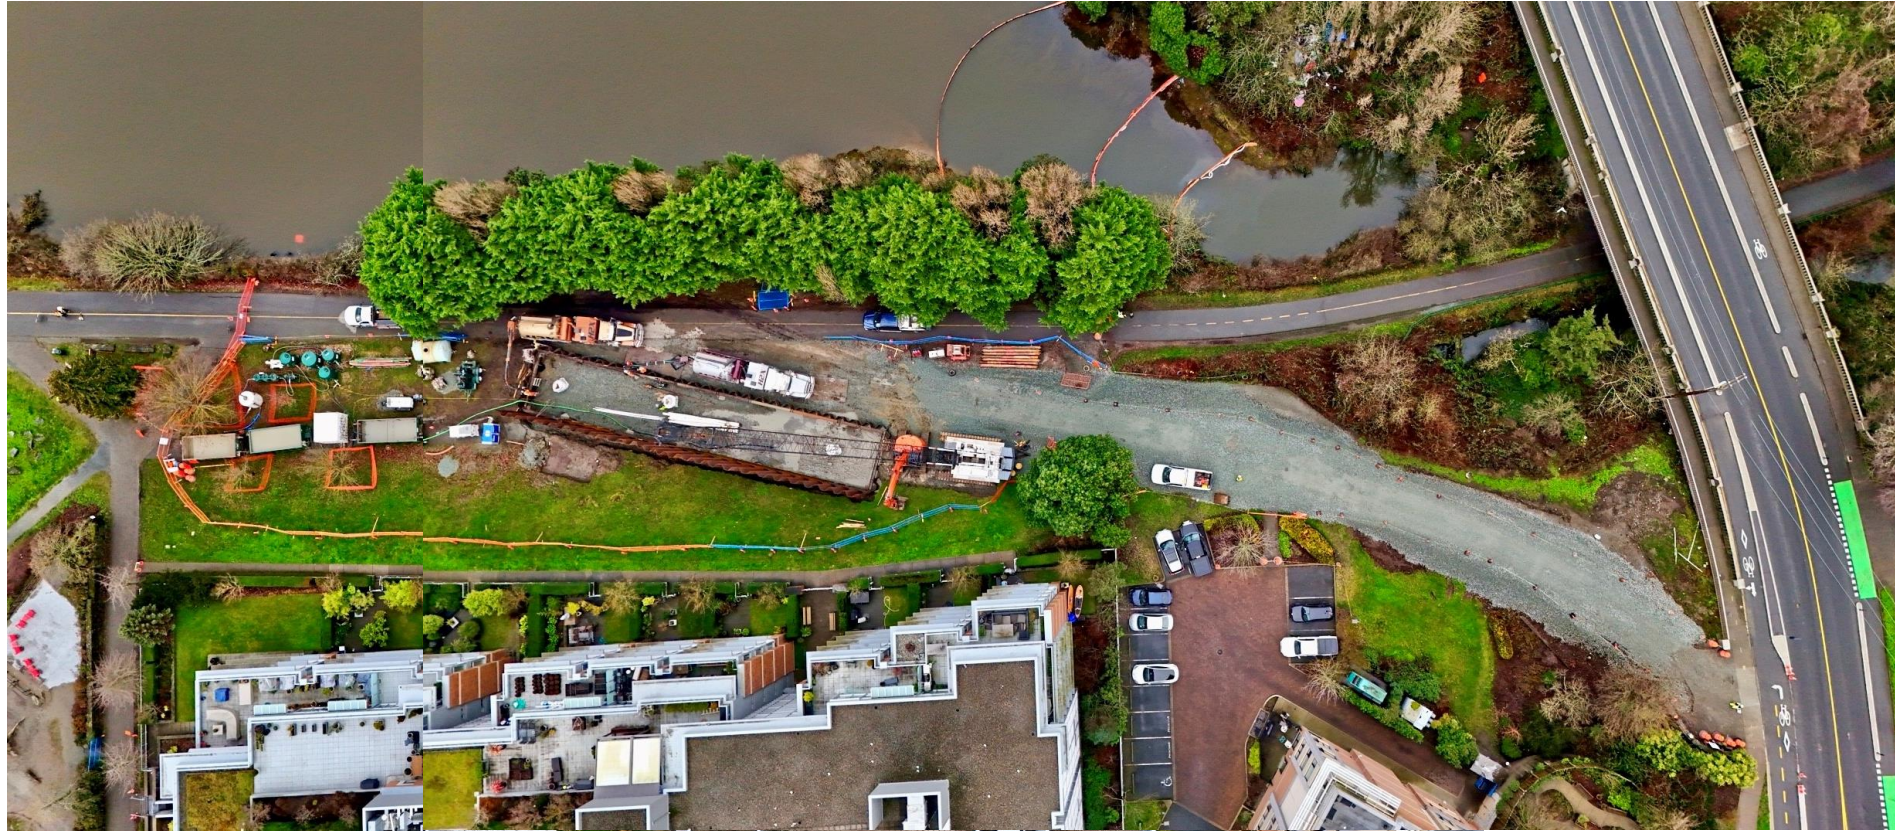
January 13: Birds-eye view (two photos joined together) of the work in Viaduct Park.

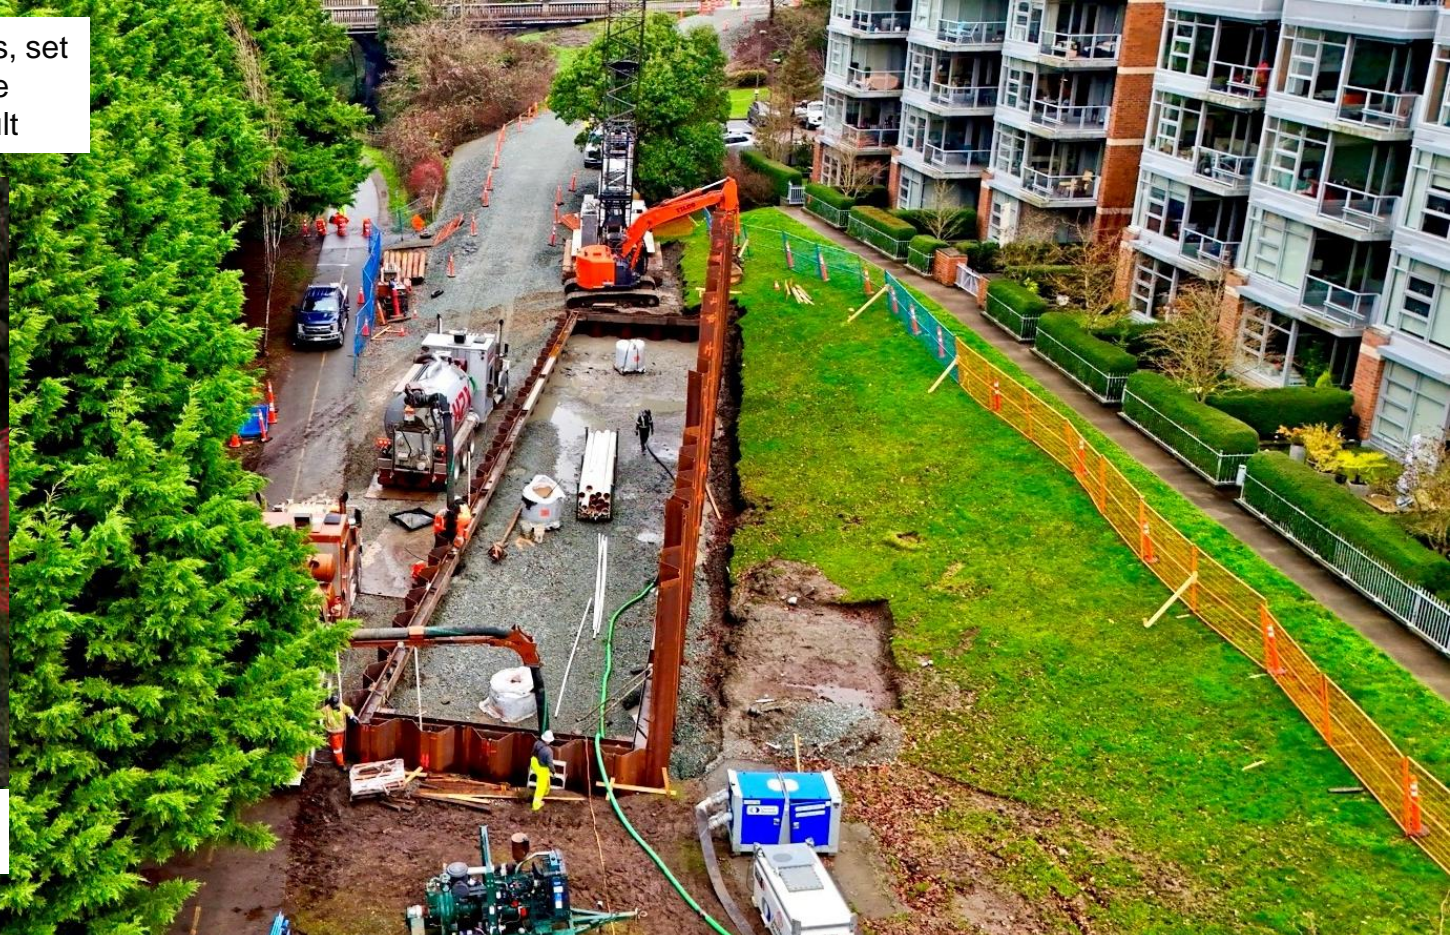
January 13: Crews beginning working on the water drainage system along the perimeter for water management during excavation.

The completed steel sheet piles, set 7 to 10 metres deep, outline the excavation for the concrete vault

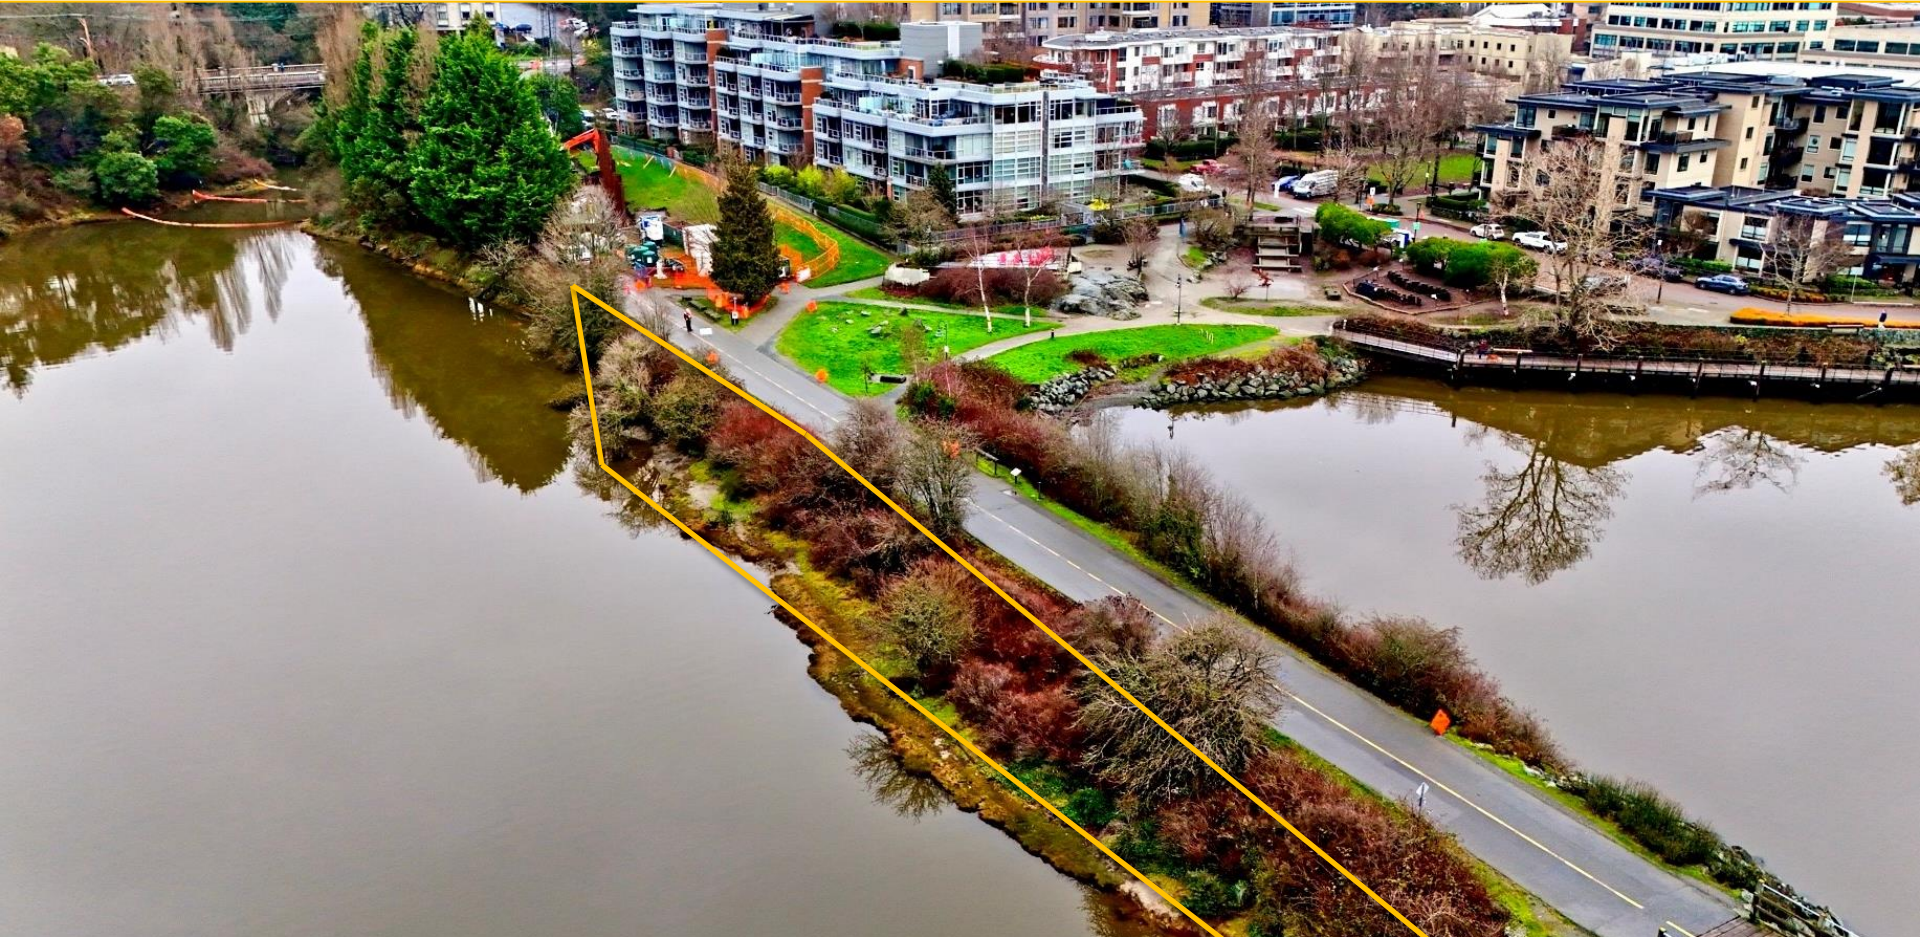
January 13: Crews will be removing brush and trees within the riparian area in early February prior to bird nesting season.
