Victoria to Esquimalt Cable Replacement Project – Update Presentation

Burnside-Gorge Community Association

Project Overview

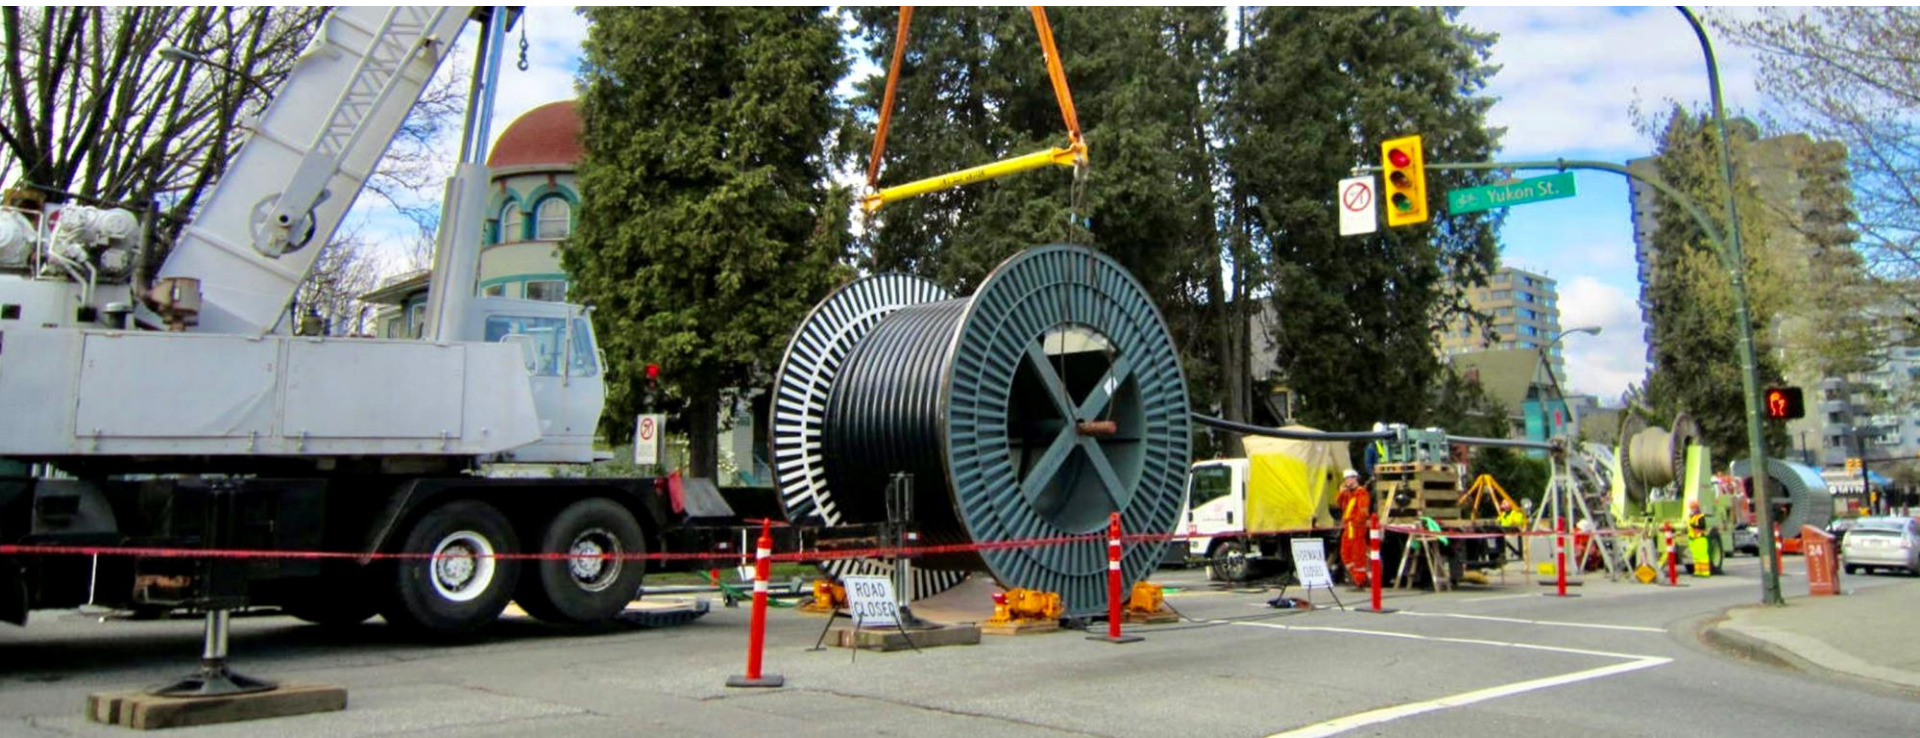
Crews will access the cable vaults that are every 500 metres or so along the route to pull through the power cable. The size of the cable supporting equipment and reels are large as shown in the photo below from a project in Vancouver. The cable pulling crew will mobilize to the five vault locations along the cable 2.7 km route starting around summer to early fall 2026.

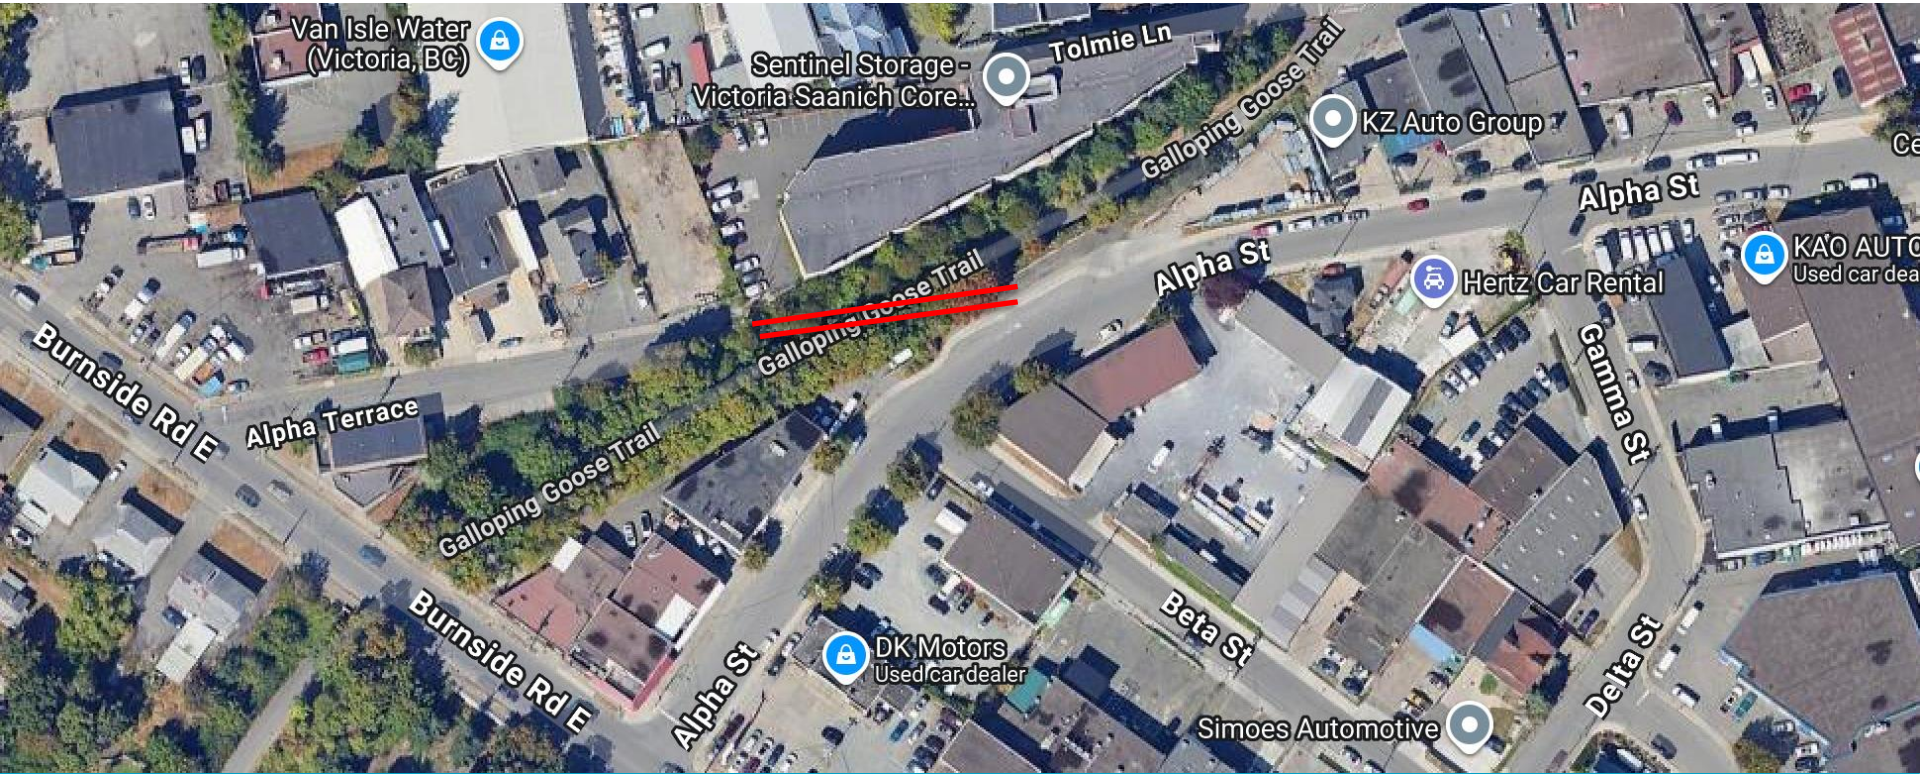
We will build about 40-50 metres of duct bank (shown by red lines) under the trail between Alpha terrace and Alpha Street during the Capital Regional District trail widening project between June and November 2026. This limits future Galloping Goose Trail closures and disruption of the trail surface with asphalt patching.
